**NCPTT 2016-17 Grants**

**Institution/Organization:**  
Program in Maritime Studies, East Carolina University

**Project title:** Coastal Heritage at Risk

## **Abstract**

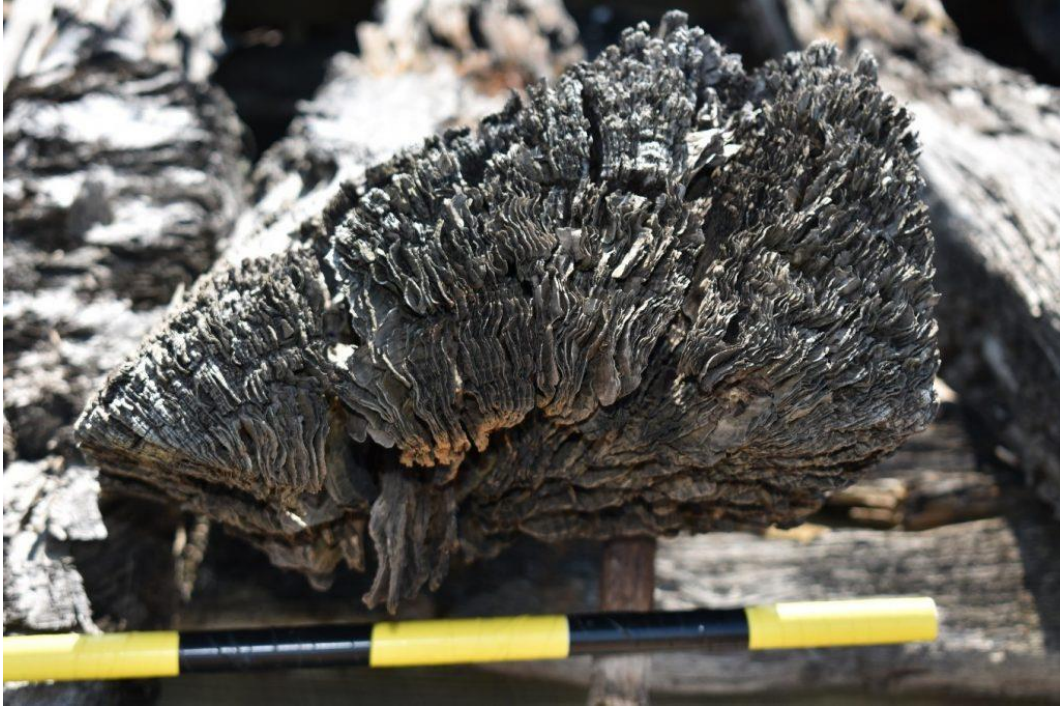
Figure 23. Eroding wood (Photo credit: by Tyler Ball, ECU)

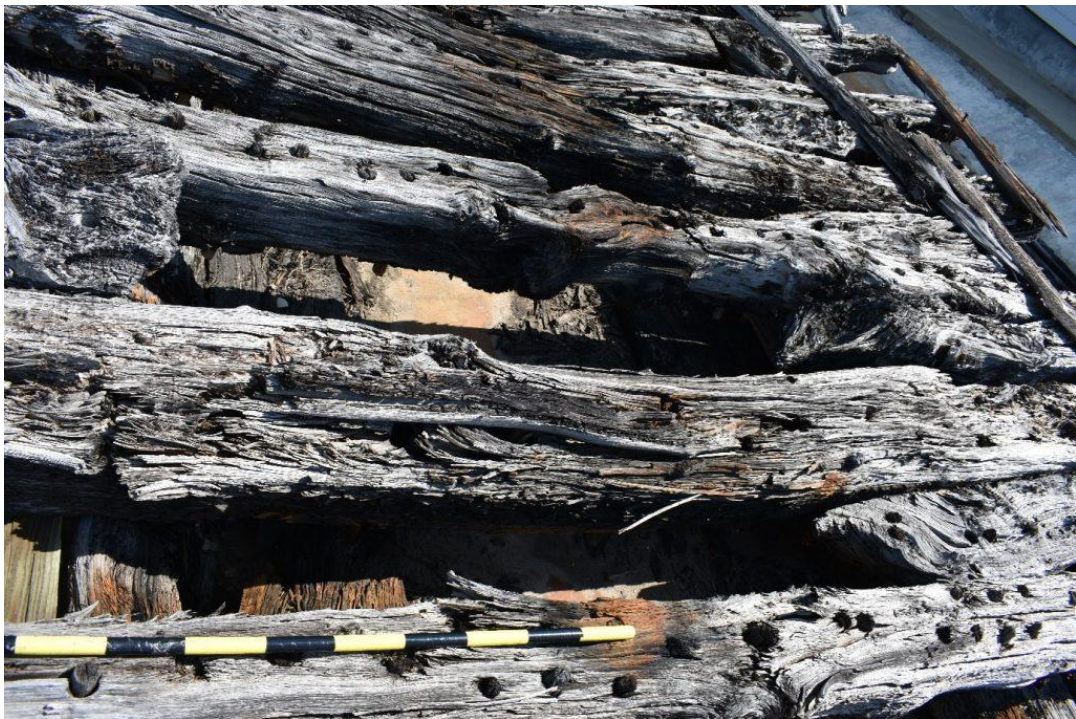
Figure 24. Frames showing bleaching, drying and severe degradation (Photo credit: Tyler Ball, ECU)

The Corolla Wreck is in a severe state of deterioration. Many of the timbers on the back half of the wreck are sagging, some to the point of caving in and breaking, and the wood is in extremely poor condition with splits in many of the frame ends. The stem and a long-curved plank lay to the left of the main wreck, with scattered pieces likely from a separate wreck sitting slightly over the curved frame. They consist of one long plank with a nail through its center and four broken planking pieces. Several other shipwreck pieces sit to the back right of the shipwreck's stern section and cannot be confirmed as associated with the wreck or not. Overall, it is clear that the Corolla Wreck has been poorly managed. To allow such an important piece of maritime history to quite literally crumble to dust is a disgrace to the profession of maritime archaeology.

Based on the current condition of the wreck, there is not much that can be done to save the remains of the vessel. The wood frames have experienced too much deterioration to go through normal conservation methods. A suggestion was made to put the remains in a mixture of water and Elmer's glue to stabilize it. The only problem with this procedure is that it is not reversible which is an important tenant in the conservation ethic is.

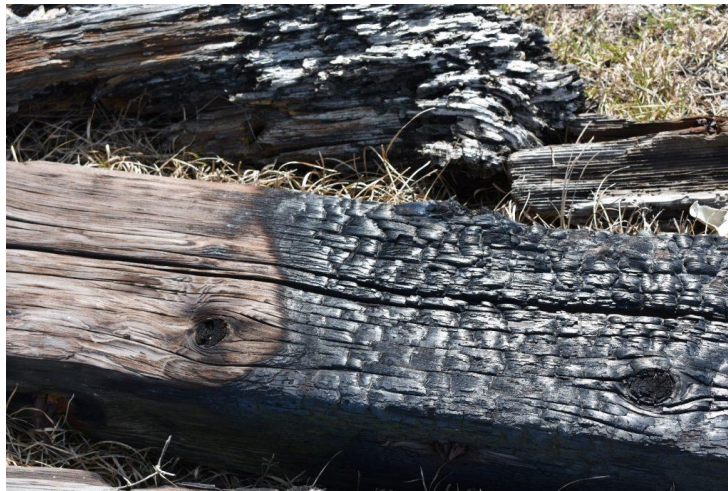
Figure 26. Burning on ship timbers (Photo Credit: Tyler Ball, ECU)

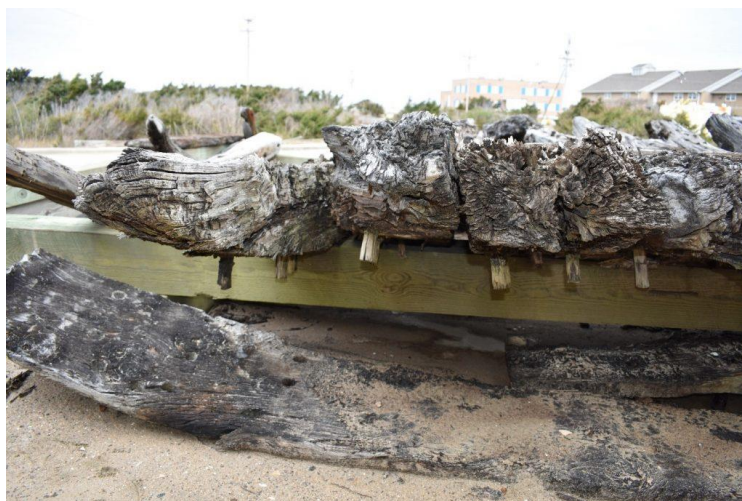
Figure 27. Shrinkage indicated by treenails protruding from frames (Photo Credit: Tyler Ball, ECU)

point aft and the timber itself is twisted, while another portion is supported by a small stack of cinder blocks. Shrinkage of the timbers is evident because nearly all of the treenail fasters extend up to ten centimeters from the timbers, where, according to Brown and other researchers, the fasteners had originally been flush with the rest of the surfaces. Many futtocks have sagged out of their original position, while the aft most starboard futtock has almost disintegrated entirely. Hull planking is also exhibiting cracks and breakage, the outermost port plank is cracked longitudinally along its entire length with one side pinned between the wreck and its support frame and the other half laying on the ground beside it. The keel and apron section are no longer attached to the main structure and lay disarticulated on the ground beside the wreck.

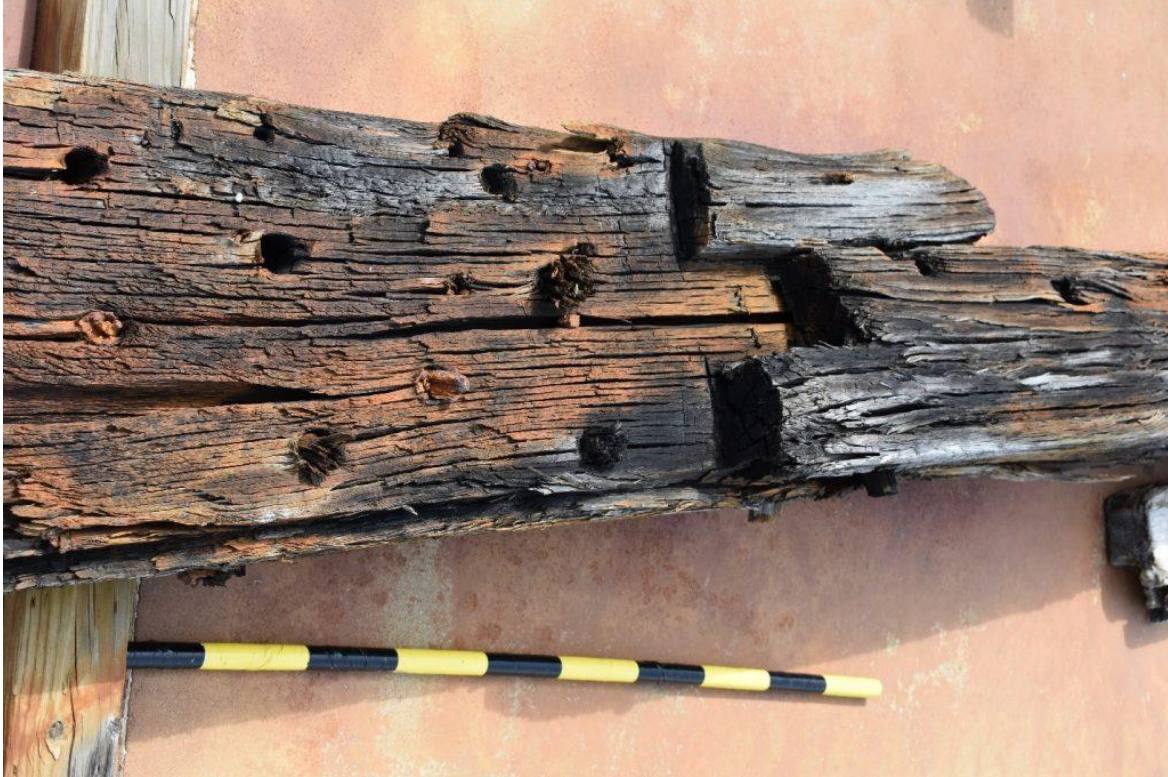
Figure 28. Rust stains on timber (Photographer Tyler Ball, ECU)

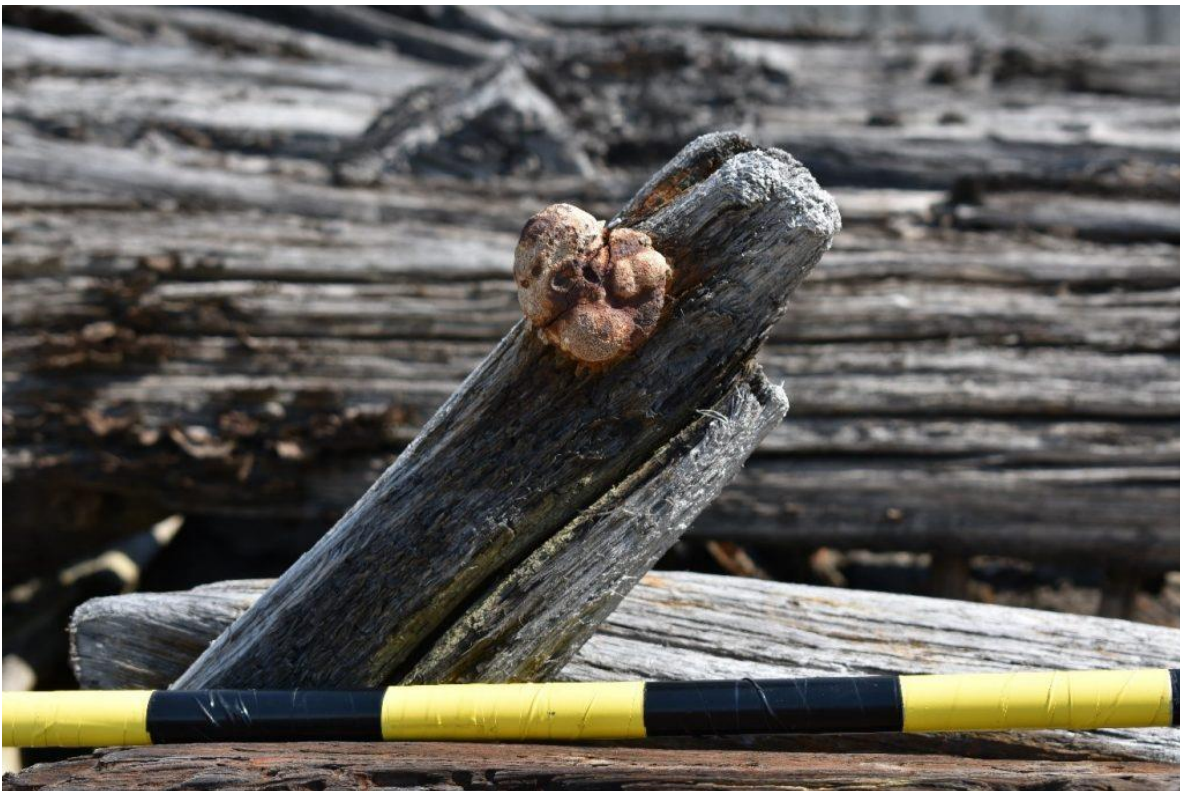
Figure 29. Rusty concretion on a timber (Photographer Tyler Ball, ECU)

impede the deterioration of wood. Several frames have broken in the middle and show iron corrosion from bolts inside the frames. Based on descriptions and pictures taken from previous surveys, the Corolla Wreck has deteriorated significantly.

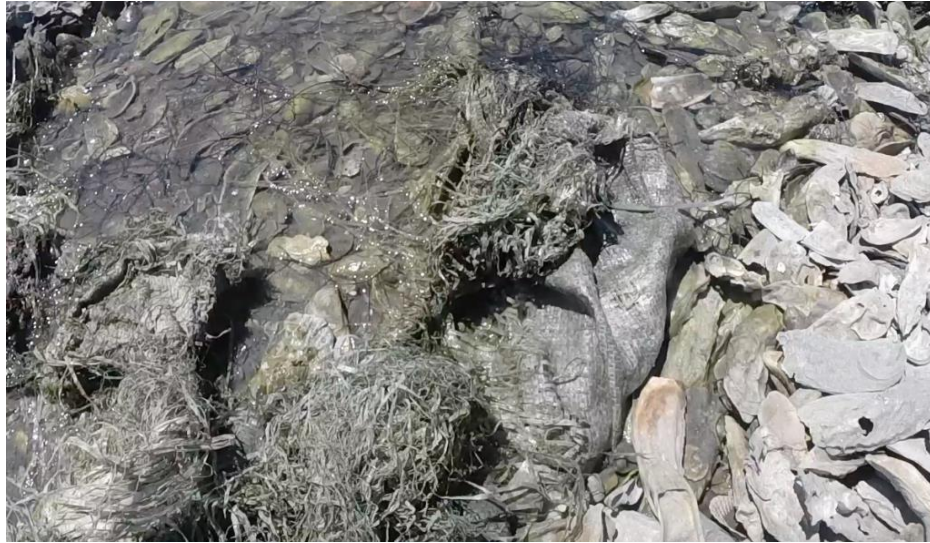
Figure 43. Stabilizing sandbags on the site shredding and eroding (Photo by Jeremy Borrelli).

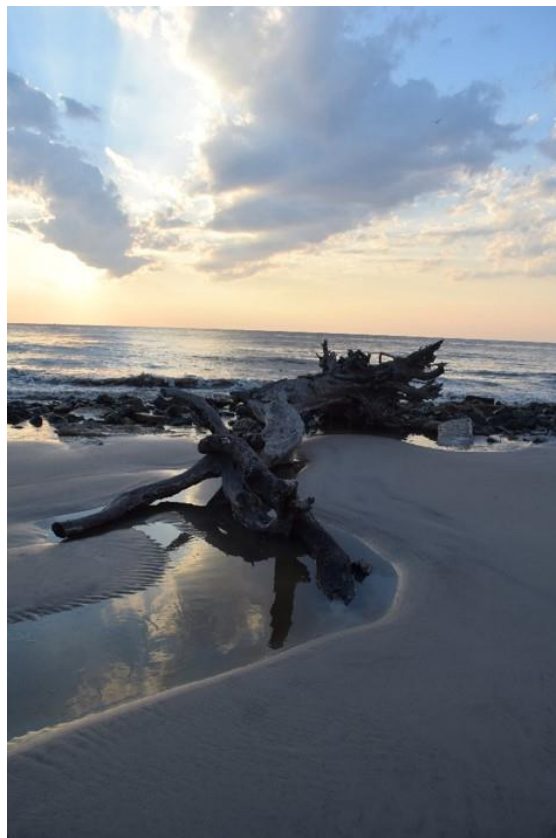
Figure 59. Driftwood caused by shoreline changes and sea encroaching on tree line (Photo by Jeremy Borrelli).

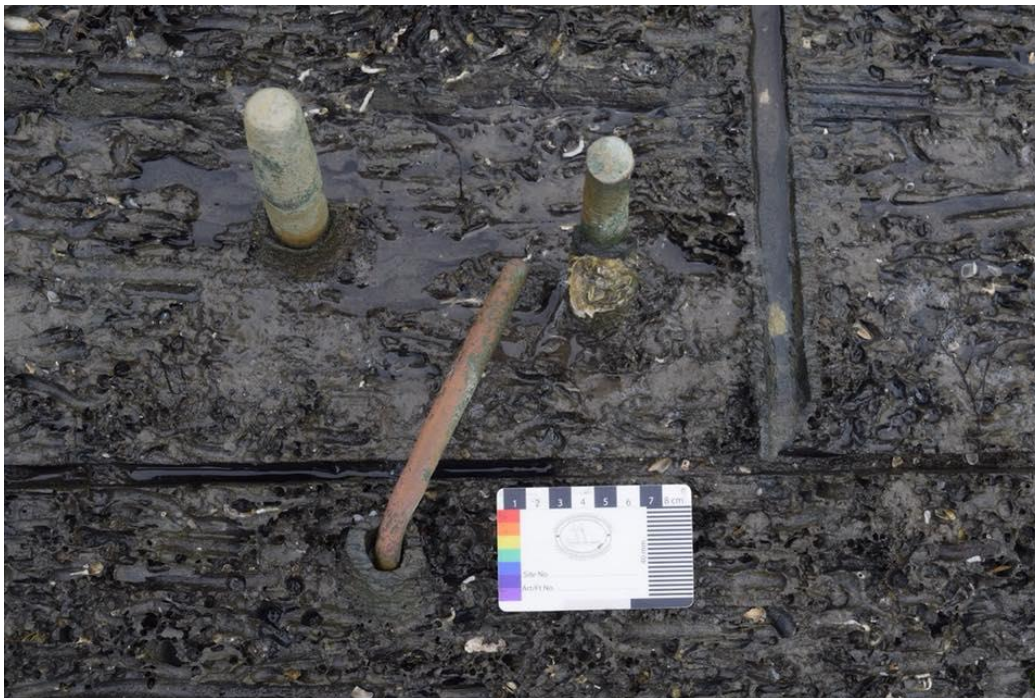
Figure 65. Copper alloy fasteners protruding from the deteriorated planking. Note the bent fastener and channel forming where the copper meets the wood (Photo by Jeremy Borrelli).

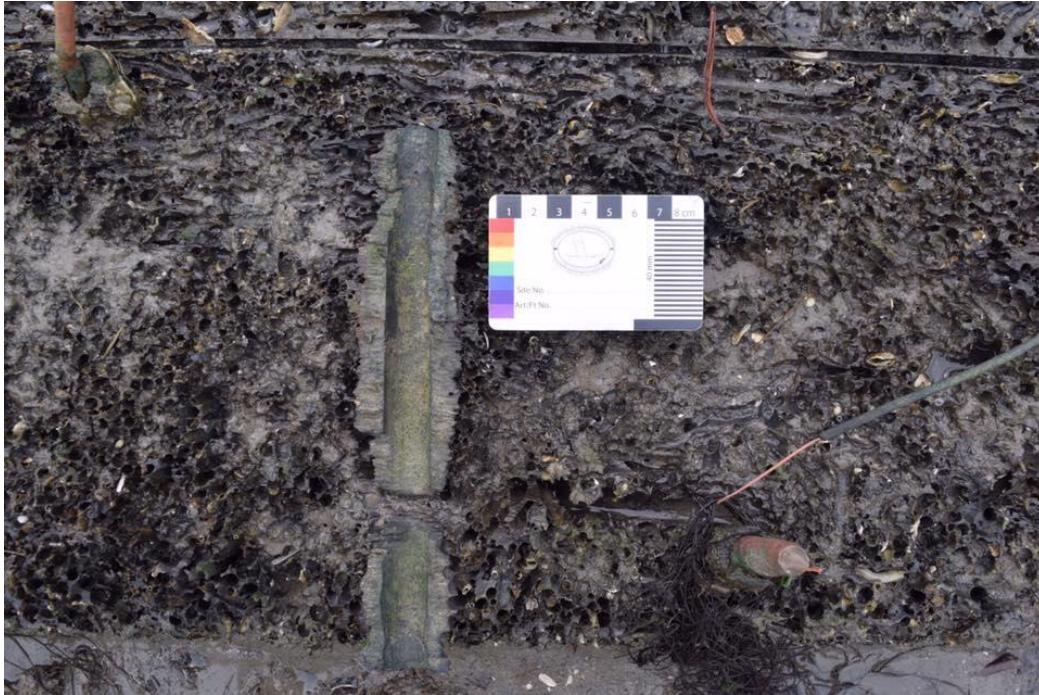
Figure 66. Evidence of edge to edge fastening of the hull planks. This fastener would have likely been near the center of the plank, suggesting the wood has degraded significantly (Photo by Jeremy Borrelli).

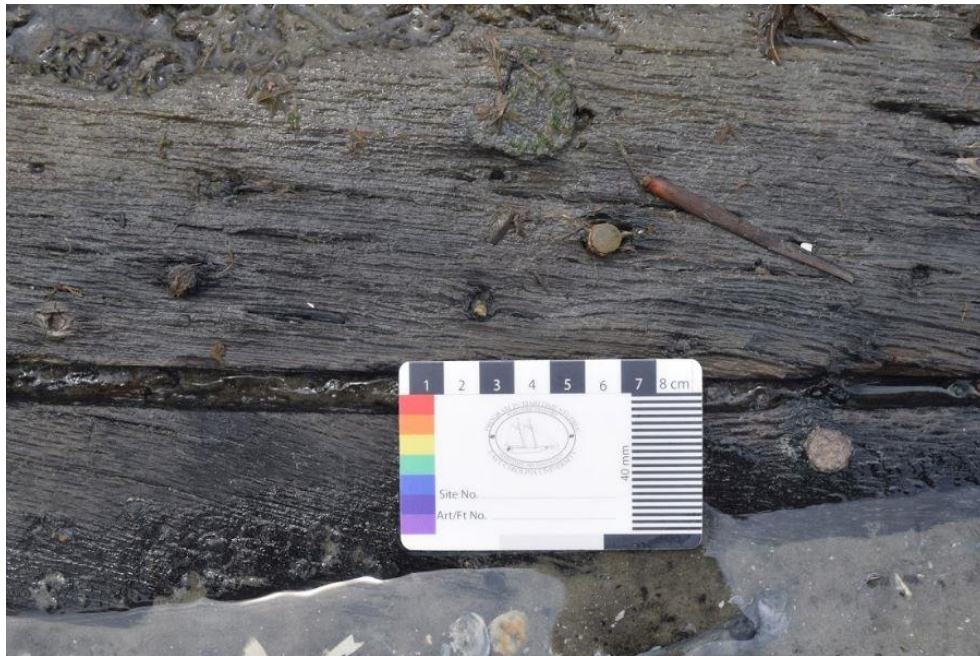
Figure 71. Sheathing tacks and burning on Wando wreck 2 in the stern area (Photo by Lynn Harris).

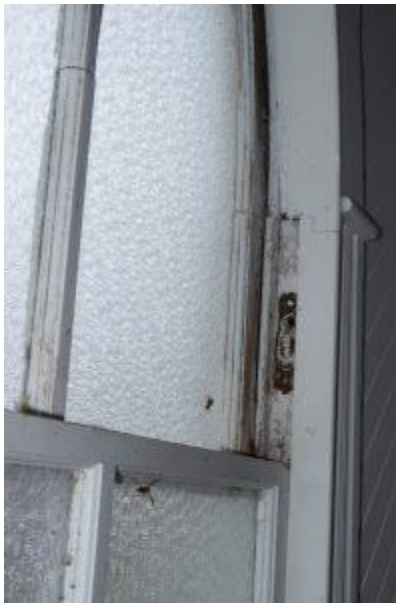
Figure 96. Example of window fixture corrosion, wasp infestation, and paint chipping on the interior (Photography by Lynn Harris).

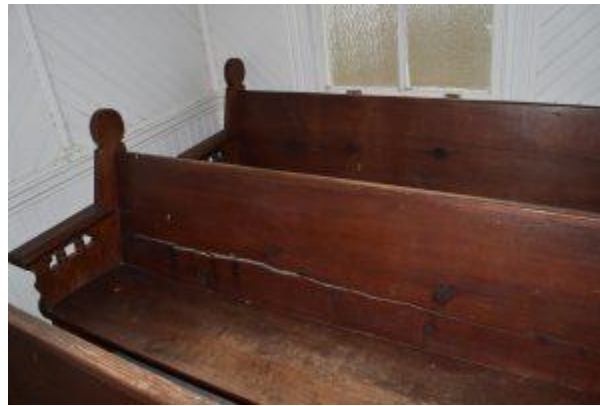
Figure 97. The current extent of damage to the backrest of a pew (Photography by Lynn Harris).  
*Post Office and General Store*

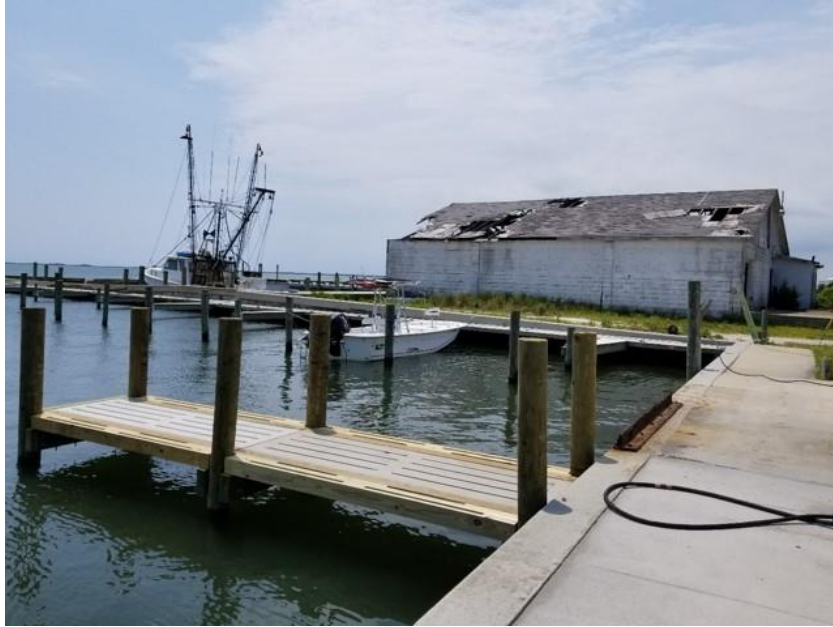
Figure 125. Roof damage of the dilapidated Old Fulcher fish house in Harker's Island built in 1940s (Photo by Lynn Harris, ECU).

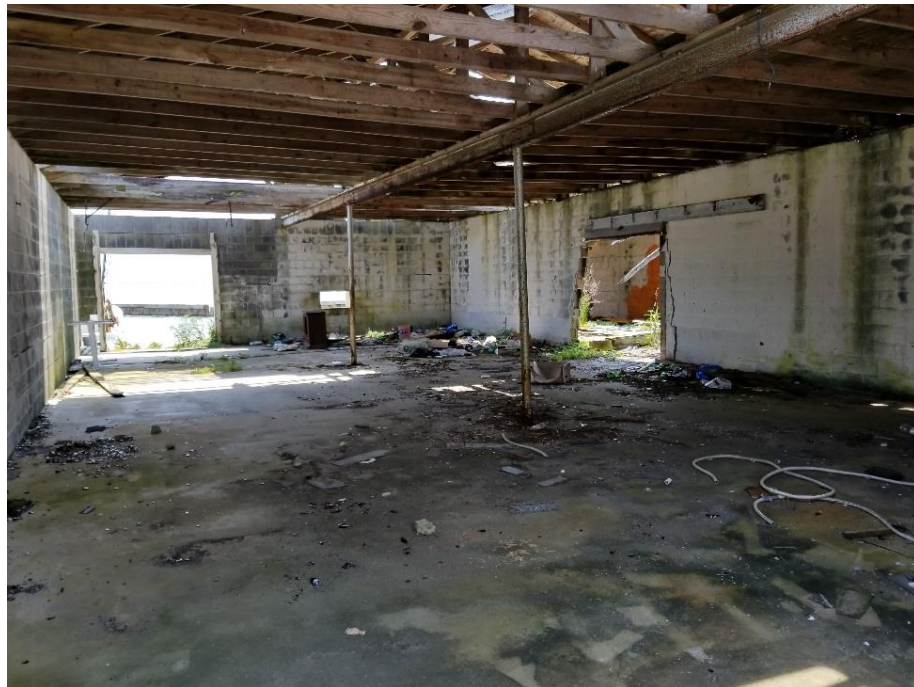
Figure 126. Interior damage of the dilapidated Old Fulcher fish house in Harker's Island built in 1940s (Photo by Lynn Harris, ECU).
