Archaeological Investigations of the Japanese Channel Light Wreck

Jennifer F. McKinnon, Sarah Nahabedian, and
Jason T. Raupp
2011

Flinders University
Program in Maritime Archaeology
Report Series
Number 2

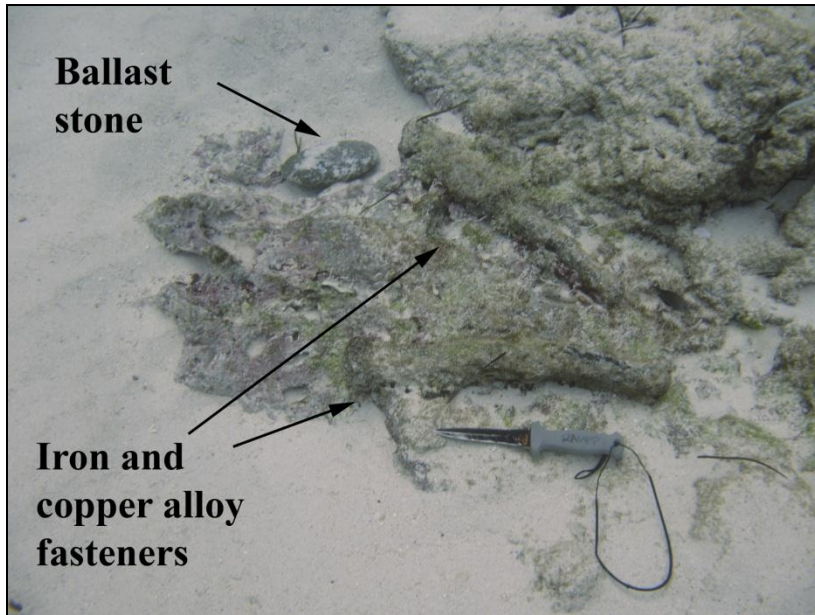
Figure 1. Ballast stone and fasteners found on the site during the 2010 investigations.

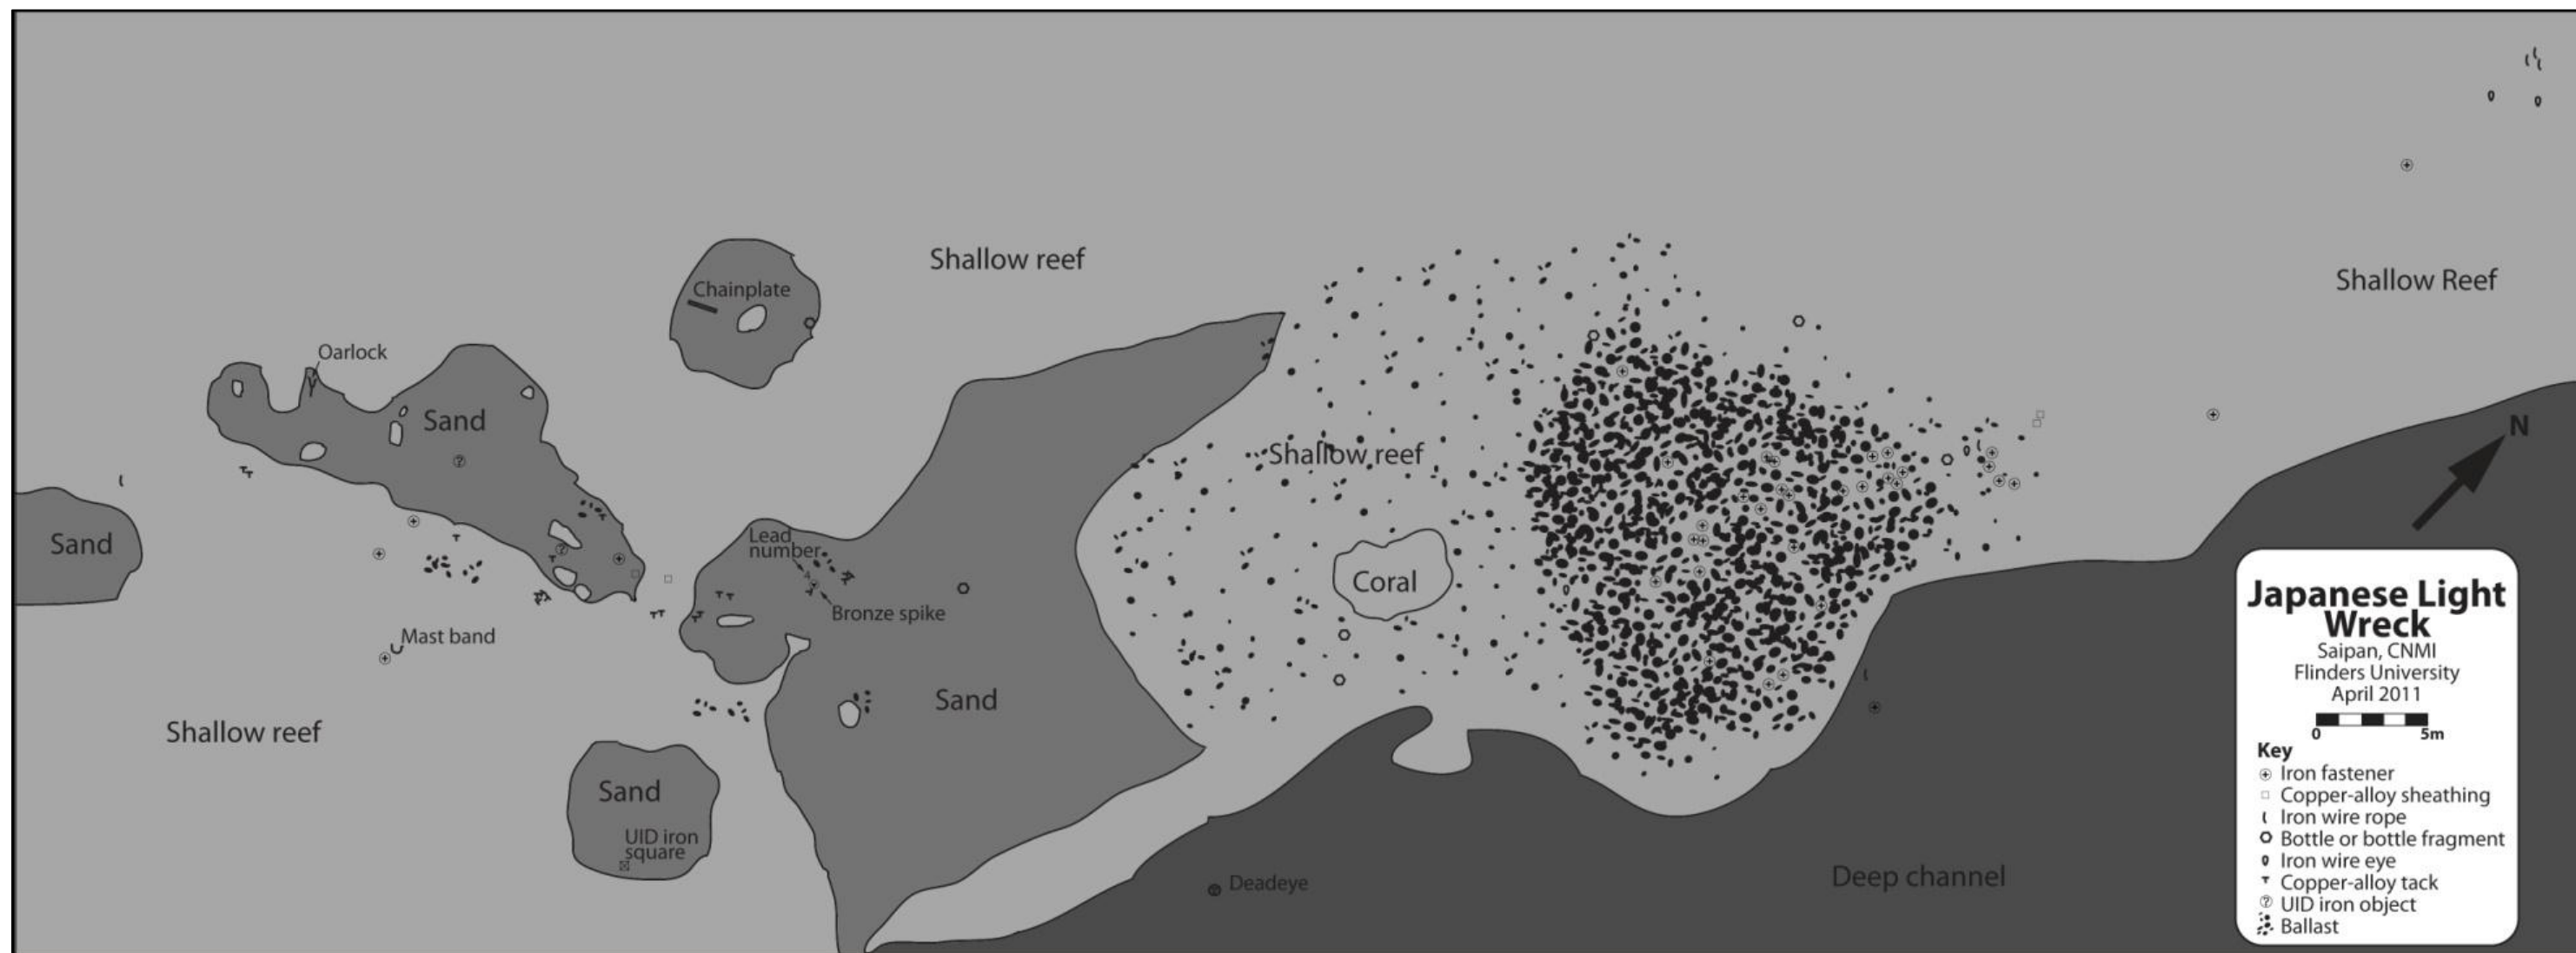
Figure 2. Site plan of Japanese Channel Light Wreck (Flinders University, April 2011).

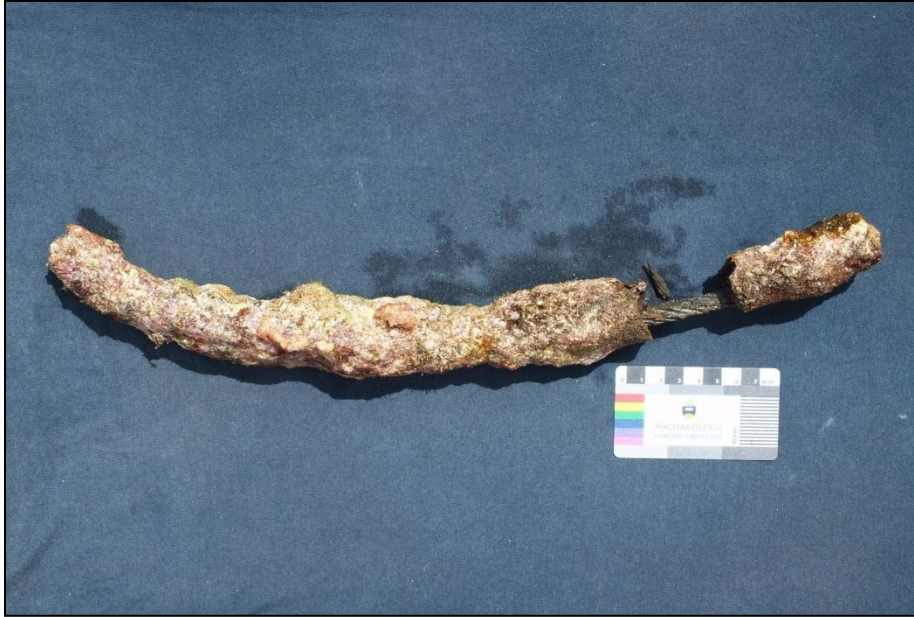
During handling of one of these samples, the concretion broke exposing the fibrous hemp core (Figure 8). Details of the rope construction were recorded and it was determined that the rope had a right-hand lay. Seen from the side, the strands lay from upper right to lower left, indicating a right-handed laid rope (Bathe 1978: 5.06). The direction of lay and the amount of torsion put into the rope varies according to the purpose for which is required (Bathe 1978: 5.08).

Figure 8. Concreted iron wire, broken exposing wire core.

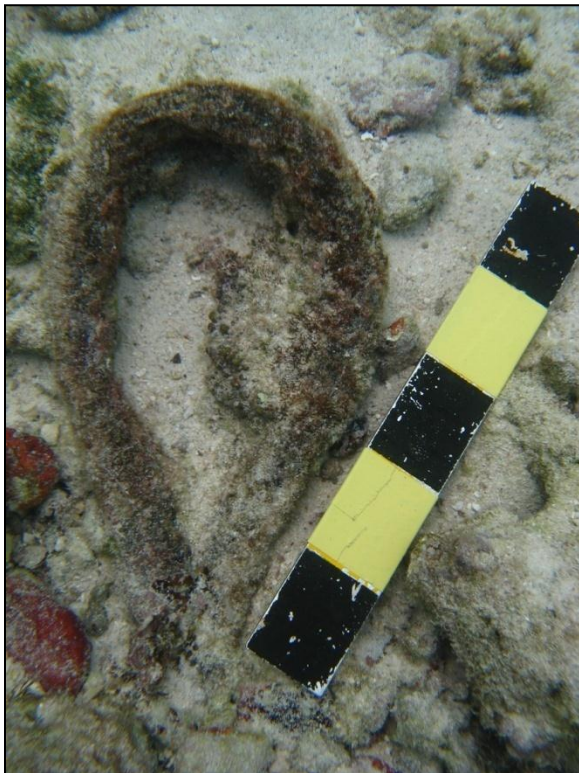
Four concreted wire eyes were also found scattered in the shallow coral reef (Figure 9). These wire eyes are made by splicing a length of wire back on itself to create an eye that was then filled with a thimble through which another rope or wire would be passed (Bathe 1978: 5.03). Most of the iron eyes found appeared to be severed at the base. Interestingly, these eyes were found in close proximity to concreted wire rope and may have been severed during the wrecking or sometime thereafter. The eye photographed below measures 28cm in length with an eye diameter (lengthwise) of 19cm.

Figure 9. Concreted iron eye with 25cm scale.

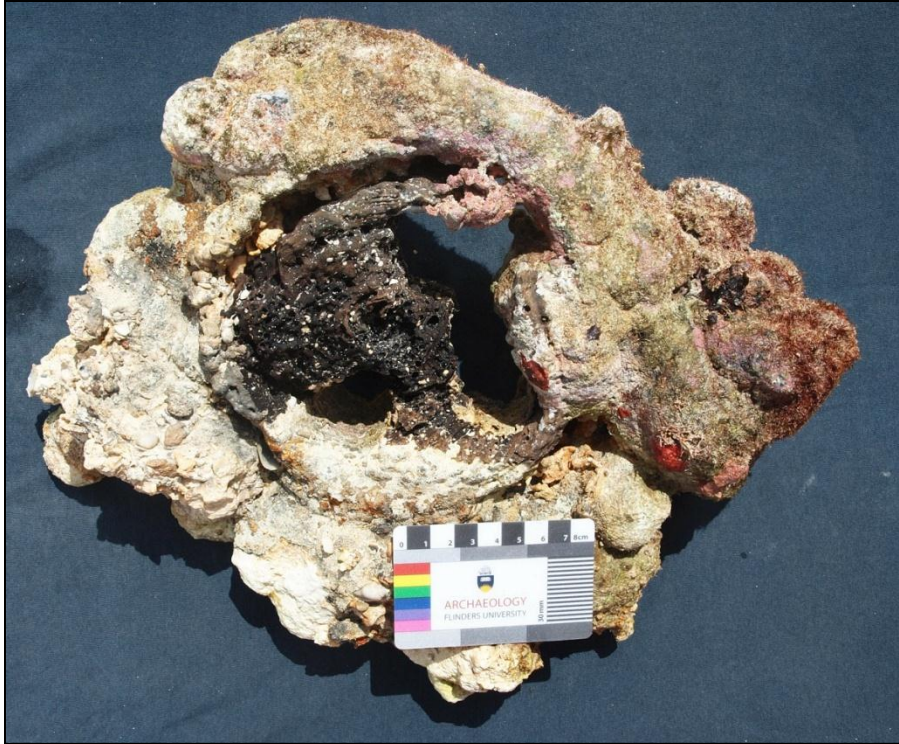
A single wood deadeye was found on the site and recovered for topside recording. This artifact measured 15cm in diameter (Figure 10) and was identified as a deadeye from the three noticeable holes in the same configuration as well-known deadeyes. Each hole is approximately 4cm wide but this may not be an accurate original measurement due to extreme deterioration of the wood. As well as the deadeye, an iron stop is fixed around the wood and ballast stones are concreted to it. The overall dimension of the concreted deadeye is 28cm tall by 37cm wide. Few timber fragments were found on the site, most likely due to the warm, shallow water and the proliferation of marine boring organisms. It is likely that the deadeye survived nearly intact due to the associated iron stop which formed a protective concretion around the deadeye, but also the fact that deadeyes are typically made out of strong woods resistant to rot and insects (i.e. *lignum vitae*). One side of the deadeye was more protected from marine growth and deterioration because it was buried in the sand which aided in the identification of the artifact.

Figure 10. Wood deadeye conglomeration with wood visible and 8cm scale.

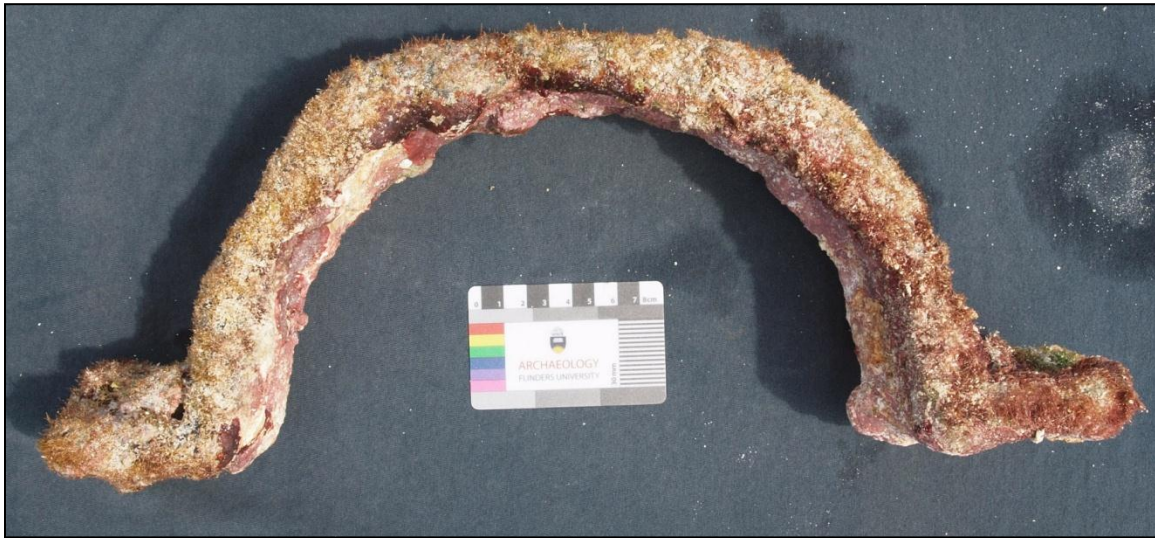
One steel or iron object in the shape of a half circle with flanges at each end was located on the site (Figure 11). The object has been identified as a portion of a mast band. The radius of the half circle is 15cm; the overall length of the object including the two flanges is 43cm; and the diameter of the inner half circle is 25cm. Red and brown algae were present growing on the exposed side of the object.

Figure 11. Steel or iron object, possibly half of a mast band with 8cm scale.

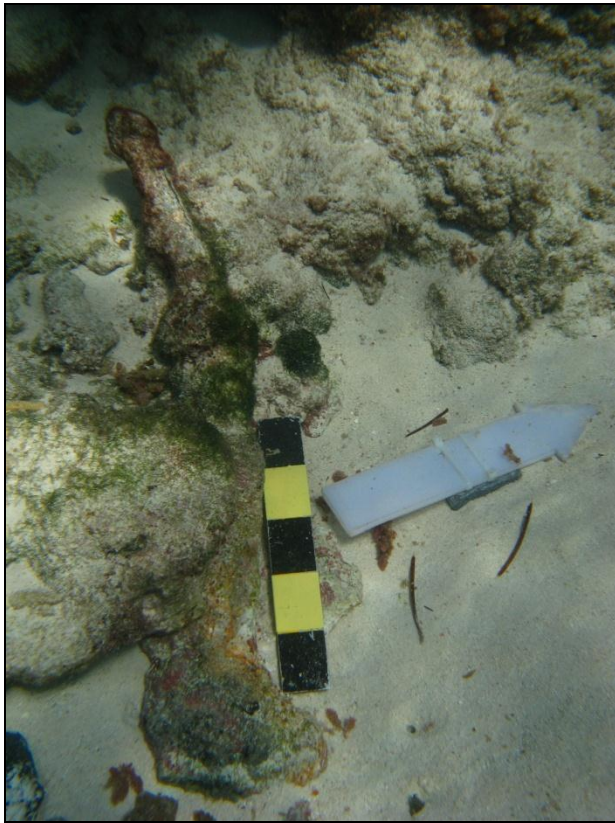
An iron object likely to be a chainplate assembly was located concreted to the seabed. Approximately 60cm in length, 4cm wide at the top, and 15cm wide at the base it was found 21m north of the baseline in a large sand pocket (Figure 13). The top of the object is circular and has a hole in its centre, although algae growth and concretion have nearly enclosed the circle. Roughly 25cm from the top, the object curves and appears fragmented, although it is uncertain if the object is comprised of multiple pieces.

Figure 13. Concreted iron object; possible chainplate with 25cm scale.

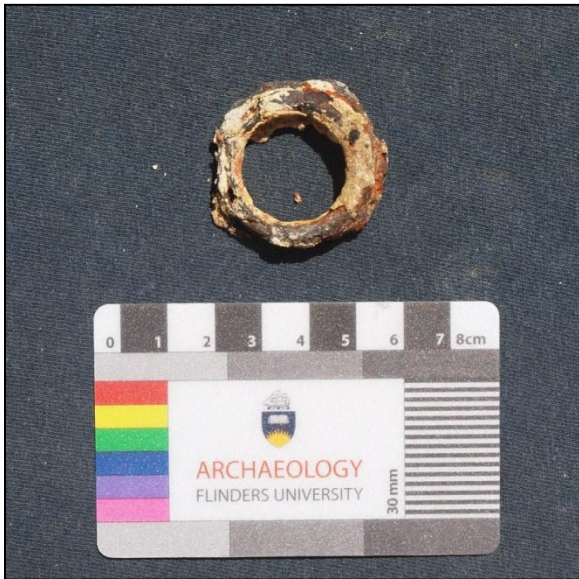
A 3.2cm diameter steel or iron ring was located during the survey (Figure 14). Though its function was not positively identified, based on its size and shape it may be the remains of a heavily deteriorated and concreted grommet. Grommets were used in sail and canvas construction for reinforcing areas where line was attached. Typically constructed of copper-alloy metals to prevent corrosion they were also made of iron or steel.

Figure 14. Iron ring with 8cm scale.

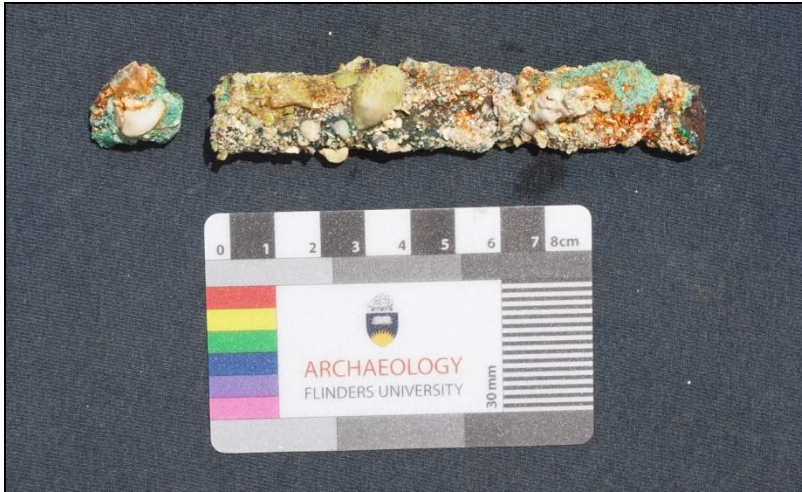
An unidentified copper-alloy band was found on the site and recovered for further identification and recording on the surface (Figure 15). Approximately 11cm long, 1.5cm wide and 3cm thick, the object does not have any diagnostic features to identify its purpose. There is shell concreted to the artifact, as well as traces of rust which suggest some iron content

Figure 15. Unidentified copper-alloy band and small object with 8cm scale.

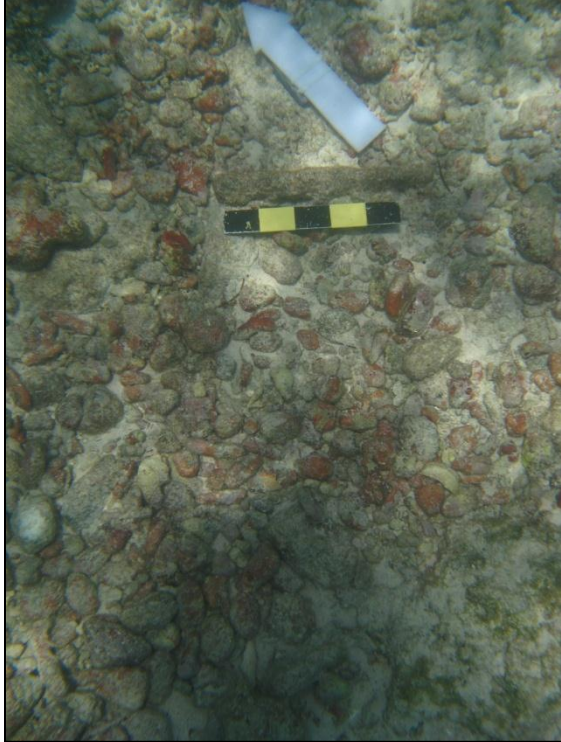
Ballast stones were found in large quantities in both concentrated areas and scattered around the site. The stones are dark black and grey, with some red algal growth on exposed surfaces (Figure 16 and Figure 17). Stones range from 3cm² to 15cm² in size and were generally oval in shape, typical of water smoothed cobble. A total of four stones were brought to the surface to photograph.

Figure 16. Ballast pile and iron fastener with 25cm scale.

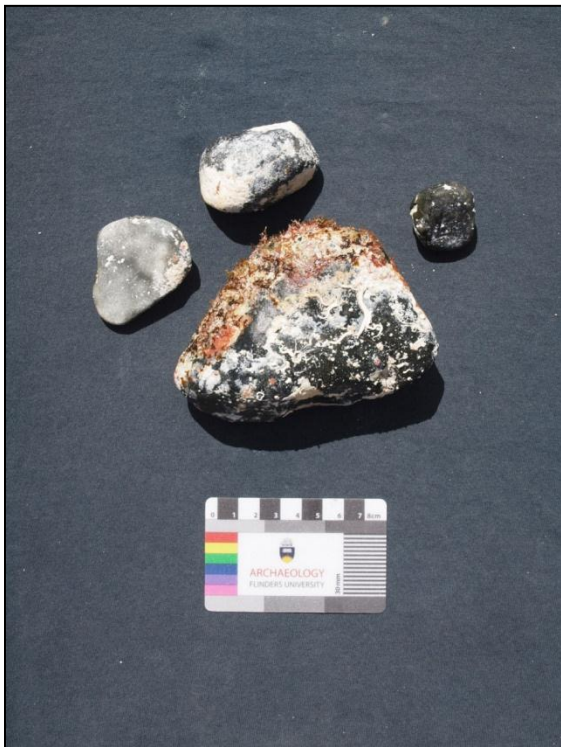
Figure 17. Recovered ballast stones with 8cm scale.

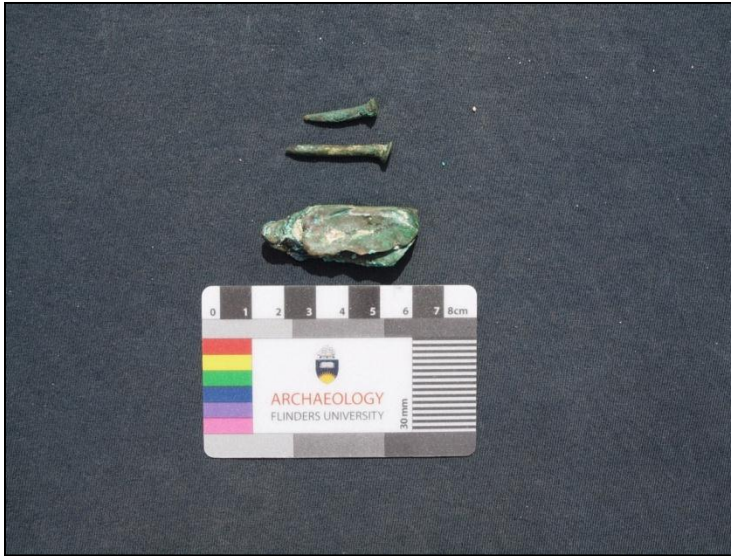
Approximately 31 copper-alloy tacks were found distributed across sand pockets in the reef (Figure 18. Two copper sheathing tacks and a folded piece of copper sheathing with 8cm scale.). These fasteners are most likely sheathing tacks due to their size and association with nearby sheathing. Of the samples recovered, the tacks were square in cross-section (approximately 0.5cm wide) with a shank width of 0.3 to 0.4cm. The tacks ranged in length from 2.2cm to 3cm.

Figure 18. Two copper sheathing tacks and a folded piece of copper sheathing with 8cm scale.

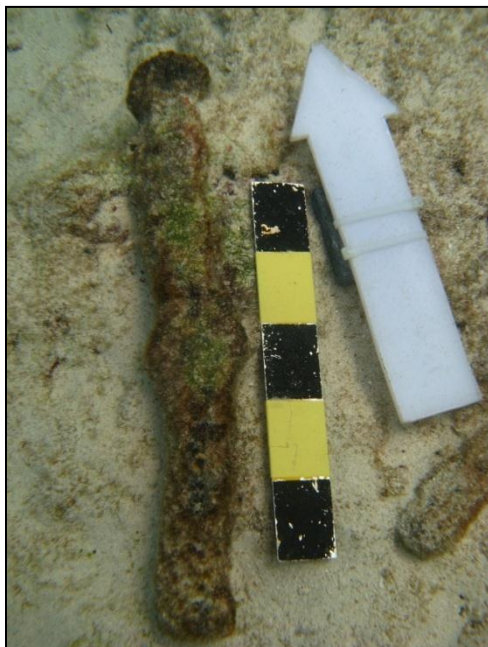
Forty-three possible iron pins or bolts were recorded affixed to the limestone substrate (Figure 19. Iron fastener with 25cm scale.). Due to the heavy iron concretion, the positive identification of these artifacts was difficult; however the general shape, straight body and presence of a head, indicated either a pin or bolt. Most of these fasteners ranged from 30-40cm long with an approximately 3.5cm diameter.

Figure 19. Iron fastener with 25cm scale.

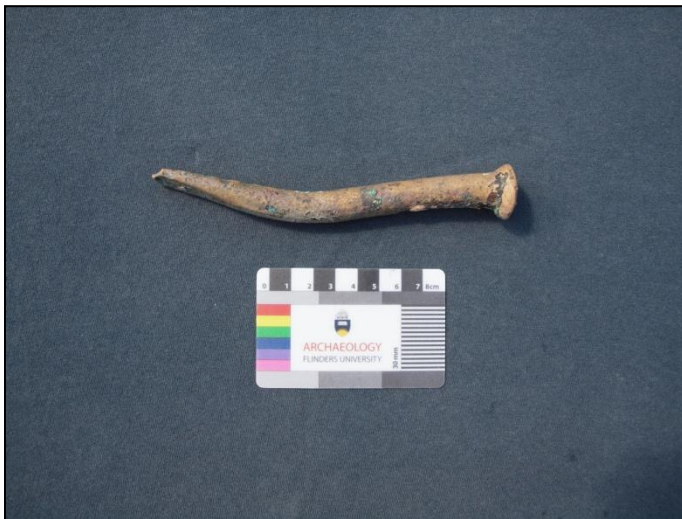
One copper-alloy fastener was found in a sand pocket and recovered for photography on the surface (Figure 20. Large copper bolt with 8cm scale.). The fastener measured 16cm long, 1.6cm wide and had a head width of 2.3cm. The fastener was tapered at one end and is bowed or curved in the middle, indicating stress at some point in its use. The exact material composition of the copper-alloy fastener is unidentifiable but is most likely bronze due to the color of corrosion materials on its surface.

Figure 20. Large copper bolt with 8cm scale.

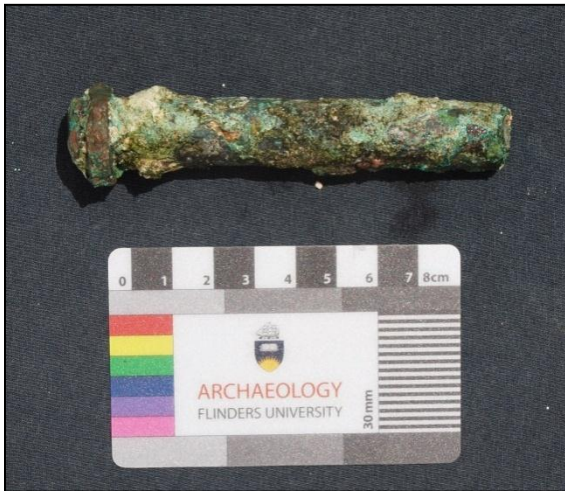
Approximately 10.5cm long with a shank width of 1.8cm, it has a head that measures 1.8cm in diameter. A square copper-alloy rove, approximately 3cm in diameter is noticeable just below the head.

Figure 21. Copper-alloy fastener with 8cm scale.

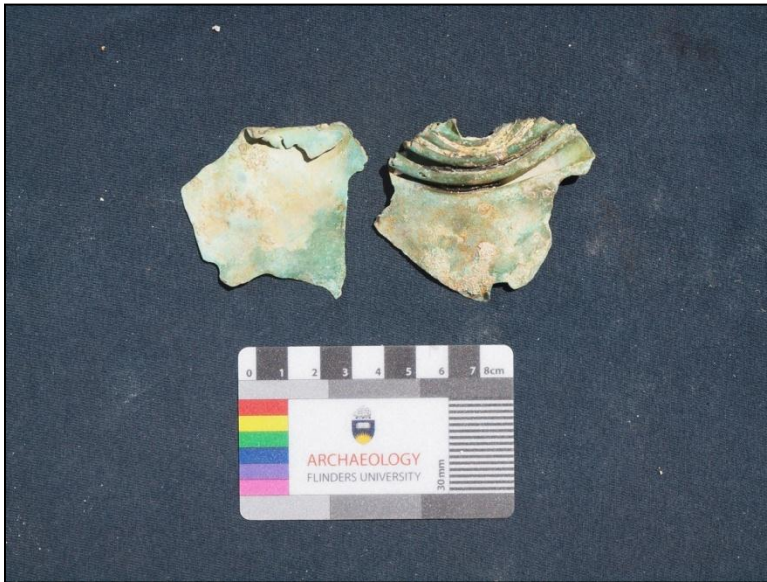
Four copper-alloy sheathing pieces were recorded both concreted into the limestone substrate and loose in sand pockets southwest of the ballast area. These pieces measured no larger than 5cm square and were in close proximity to copper tacks or fasteners. Many smaller pieces were also located concreted into the rocky limestone substrate but were unable to be recorded due to their proliferation (Figure 22). The copper was easily

Figure 22. Copper sheathing fragments with 8cm scale.

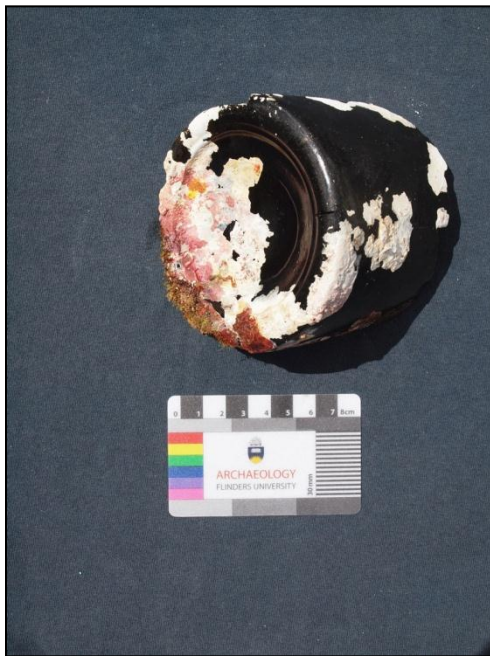
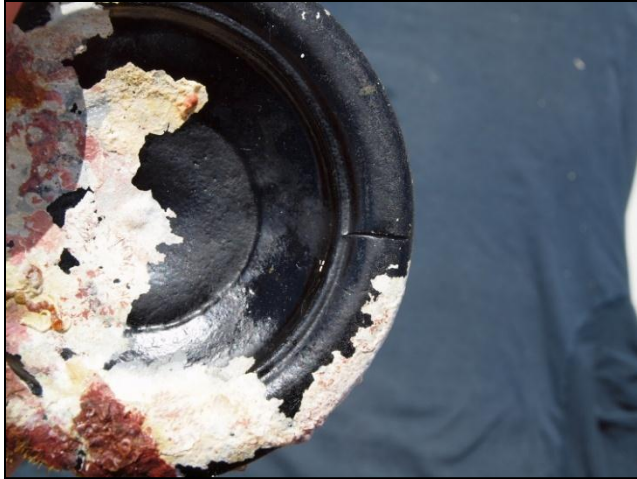
A dark green glass bottle base was found on the site (Figure 23 and Figure 24) that measured 10.5cm diameter at the base and had a wall thickness of 0.7cm. The bottom of the bottle exhibits a “kick-up,” concave or dome form (Jones and Sullivan 1989; 113), and a small cut in the base edge. The kick-up suggests the bottle was used in the transportation and storage of wine or alcoholic beverages.

Figure 23. Basal and side view with 8cm scale.

Figure 24. Close-up of base exhibiting small cut and three separate lips.

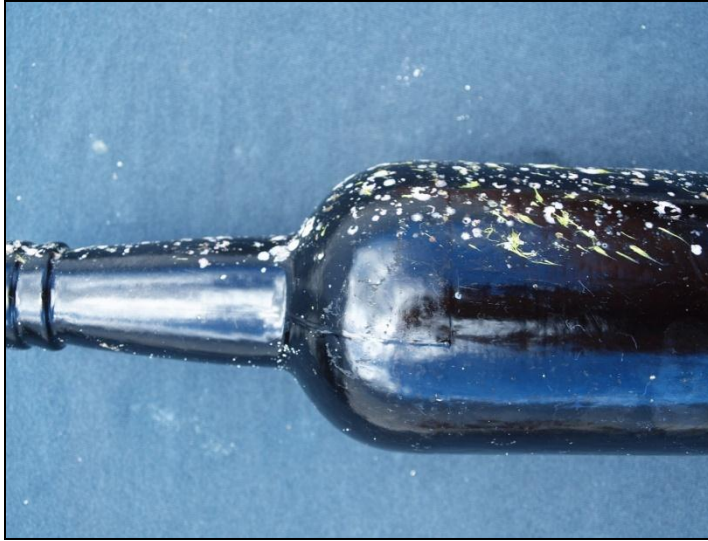
Another dark green bottle exhibiting an applied lip was recovered for topside photographs (Figure 25). The bottle measures 30cm tall and 9cm in diameter and displays a seam running along the circumference of the shoulder approximately 4cm below the neck, as well as two seams running along the body. The lines indicate the bottle was constructed in a three-piece mould.

Figure 25. Green glass 3-piece mould bottle exhibiting horizontal seam around shoulder.

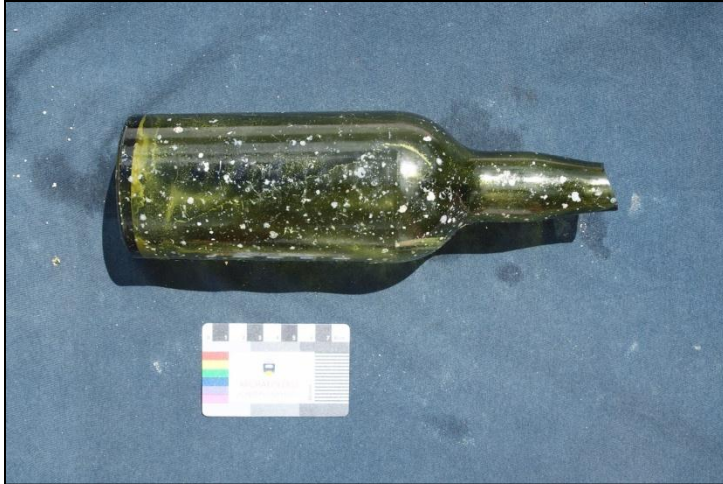
Another green glass bottle was recovered from the site for surface photography (Figure 26). The bottle is intact except for the lip and is made of a lighter green glass. A faint horizontal seam around the shoulder is visible, possibly indicating a two-piece mould construction.

Figure 26. Green glass bottle with broken lip and 8cm scale.

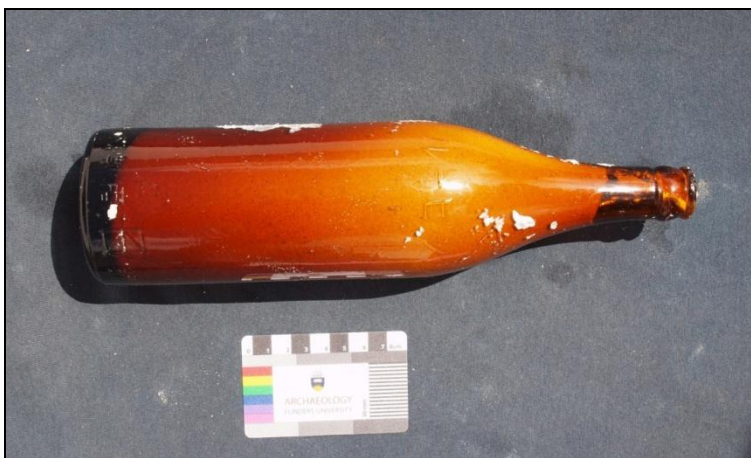
Three amber-colored glass bottles were found on the site in different locations (Figure 27). Two of these are Japanese bottles with embossed lettering “DNB” and a crown cap. One of these bottles exhibits a two-piece horizontal mould and the other was covered with algae on the exposed side which prevented the detection of the mould seam. The artifacts are assessed as twentieth century Japanese bottles.

Figure 27. Amber-coloured bottle exhibiting Japanese writing embossed into shoulder with 8cm scale.

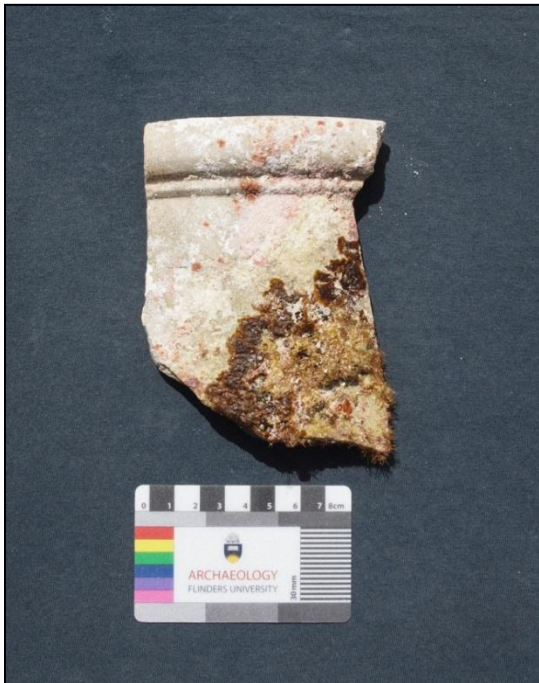
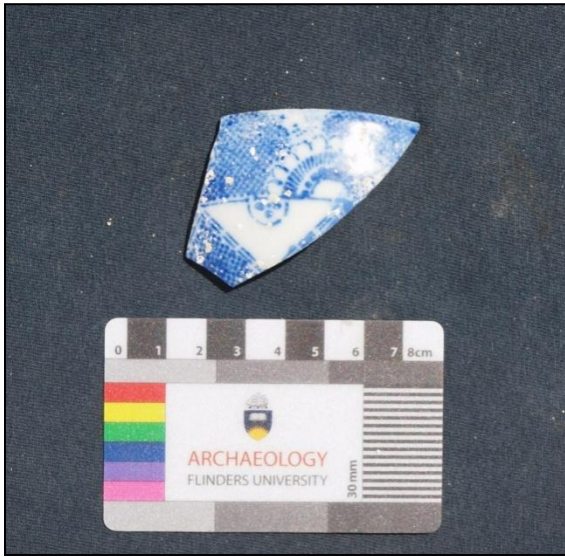
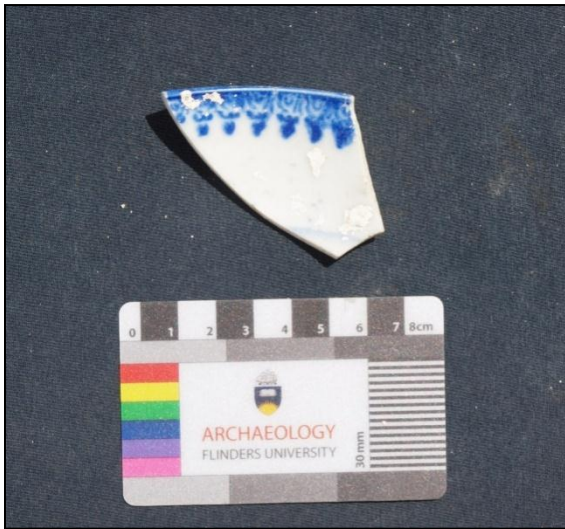
One piece of blue on white porcelain was found on the site and recovered for surface photography. The fragment is decorated on both sides with geometric and floral patterns and is 3cm thick (Figure 29 and Figure 30). This sherd could possibly belong to either a shallow bowl or saucer, as the reconstructed diameter of the fragment is 4cm.

Figure 28. Exterior of ceramic fragment with 8cm scale.

Figure 29. Porcelain fragment with 8cm scale.

Figure 30. Porcelain fragment interior view.

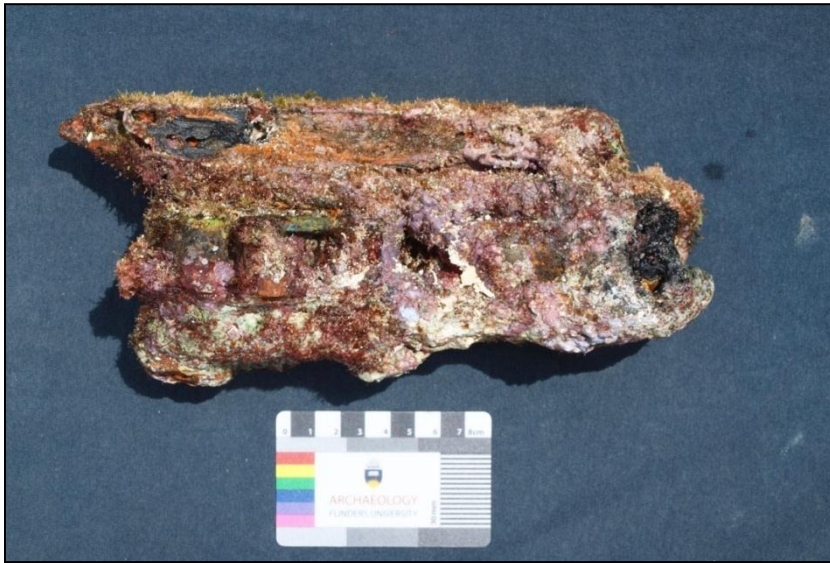
An unidentified conglomeration of wood, iron and copper-alloy metal was located and brought to the surface for recording (Figure 31). The conglomeration was covered in red and brown algae and exhibits rust and corrosion the around metal remnants. No part of the object was identifiable; however a timber sample was obtained for possible species identification.

Figure 31. Unidentified wood conglomeration, timber sample was taken from this fragment with 8cm scale.

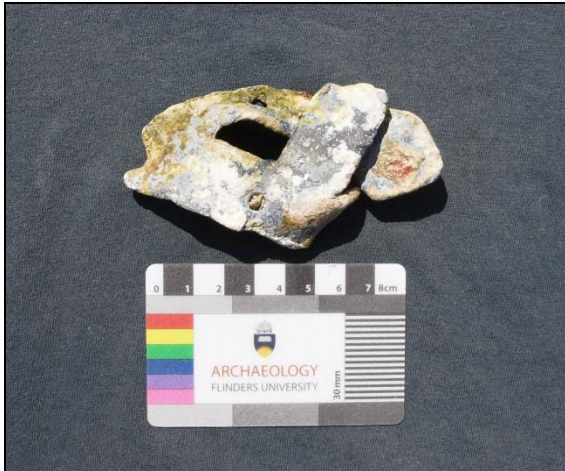
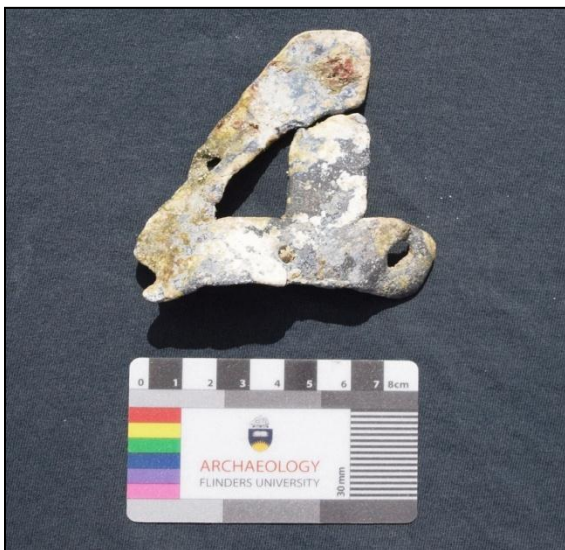
A peculiar lead object was identified in a sand pocket and recovered for recording on the surface. Initially folded, the artifact was carefully unfolded to reveal the shape of an Arabic number "4" with the base missing (Figure 33 and Figure 34). The lead artifact was not manipulated in any other way except to fold it flat for recording purposes. The object is roughly 9cm tall, 0.2cm thick and is perforated by three small holes. The holes do not appear in any particular pattern and are fastener holes through which small tacks would have attached it probably to wood. If the lead object is in fact a number, it might have been a vessel's draught number or cabin number.

Figure 33. Folded piece of lead in initial state found with 8cm scale.

Figure 34. Lead artifact unrolled to lie flat, appearing as the number “4” with three small holes and 8cm scale.

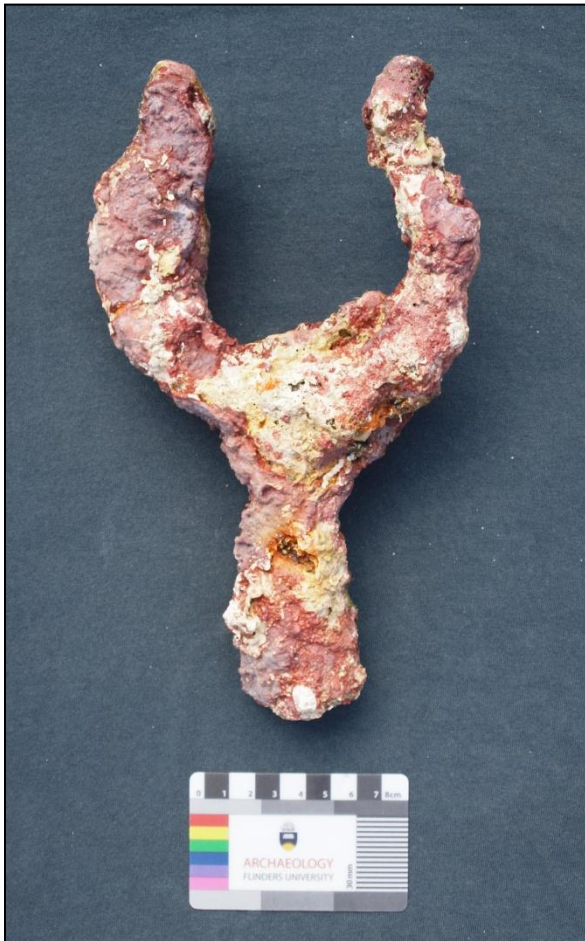
A heavily concreted metal oarlock was found in a large sand pocket and recovered for surface recording (Figure 35). Also known as a rowlock, these were u-shaped metal swivels that mounted on ships' boat's gunwales to accommodate an oar (Bathe 1978: 9.02). This object was easily distinguished by its general form and exhibits a ribbed horn-style opening 10cm wide, a straight shank 5cm in width and its overall length is 25.5cm (all measurements include concretion). This oarlock is most likely associated with a gig or lifeboat, would have been propelled by oars (Bathe 1978: 9.01).

Figure 35. Oarlock exhibiting heavy concretion with 8cm scale.

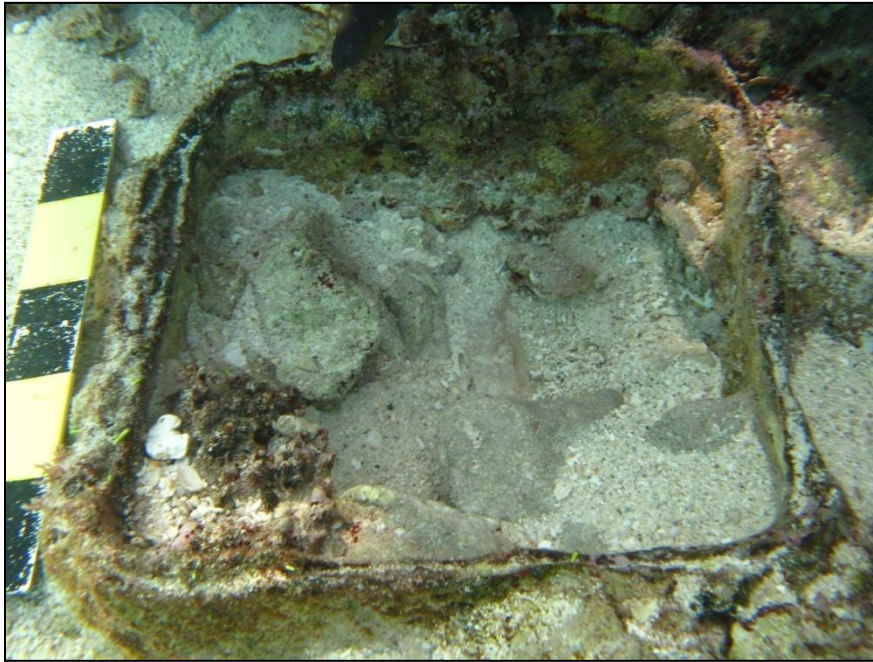
An unidentified metal box-like artifact was also located embedded in the coral reef. Square in shape and with rounded edges, it measures 30cm² and 6cm deep and does not appear to have a bottom (Figure 36). Though the object has no diagnostic features to identify its function, possible uses associated with nineteenth century sailing vessels include an anchor stock band or spar band.

Figure 36. Unidentified iron square with 25cm scale.
