Helical Screw Pile From Roanoke Marshes Light Croatan Sound, NC (1877-1955)

Pre-treatment drawing 18 September 2013

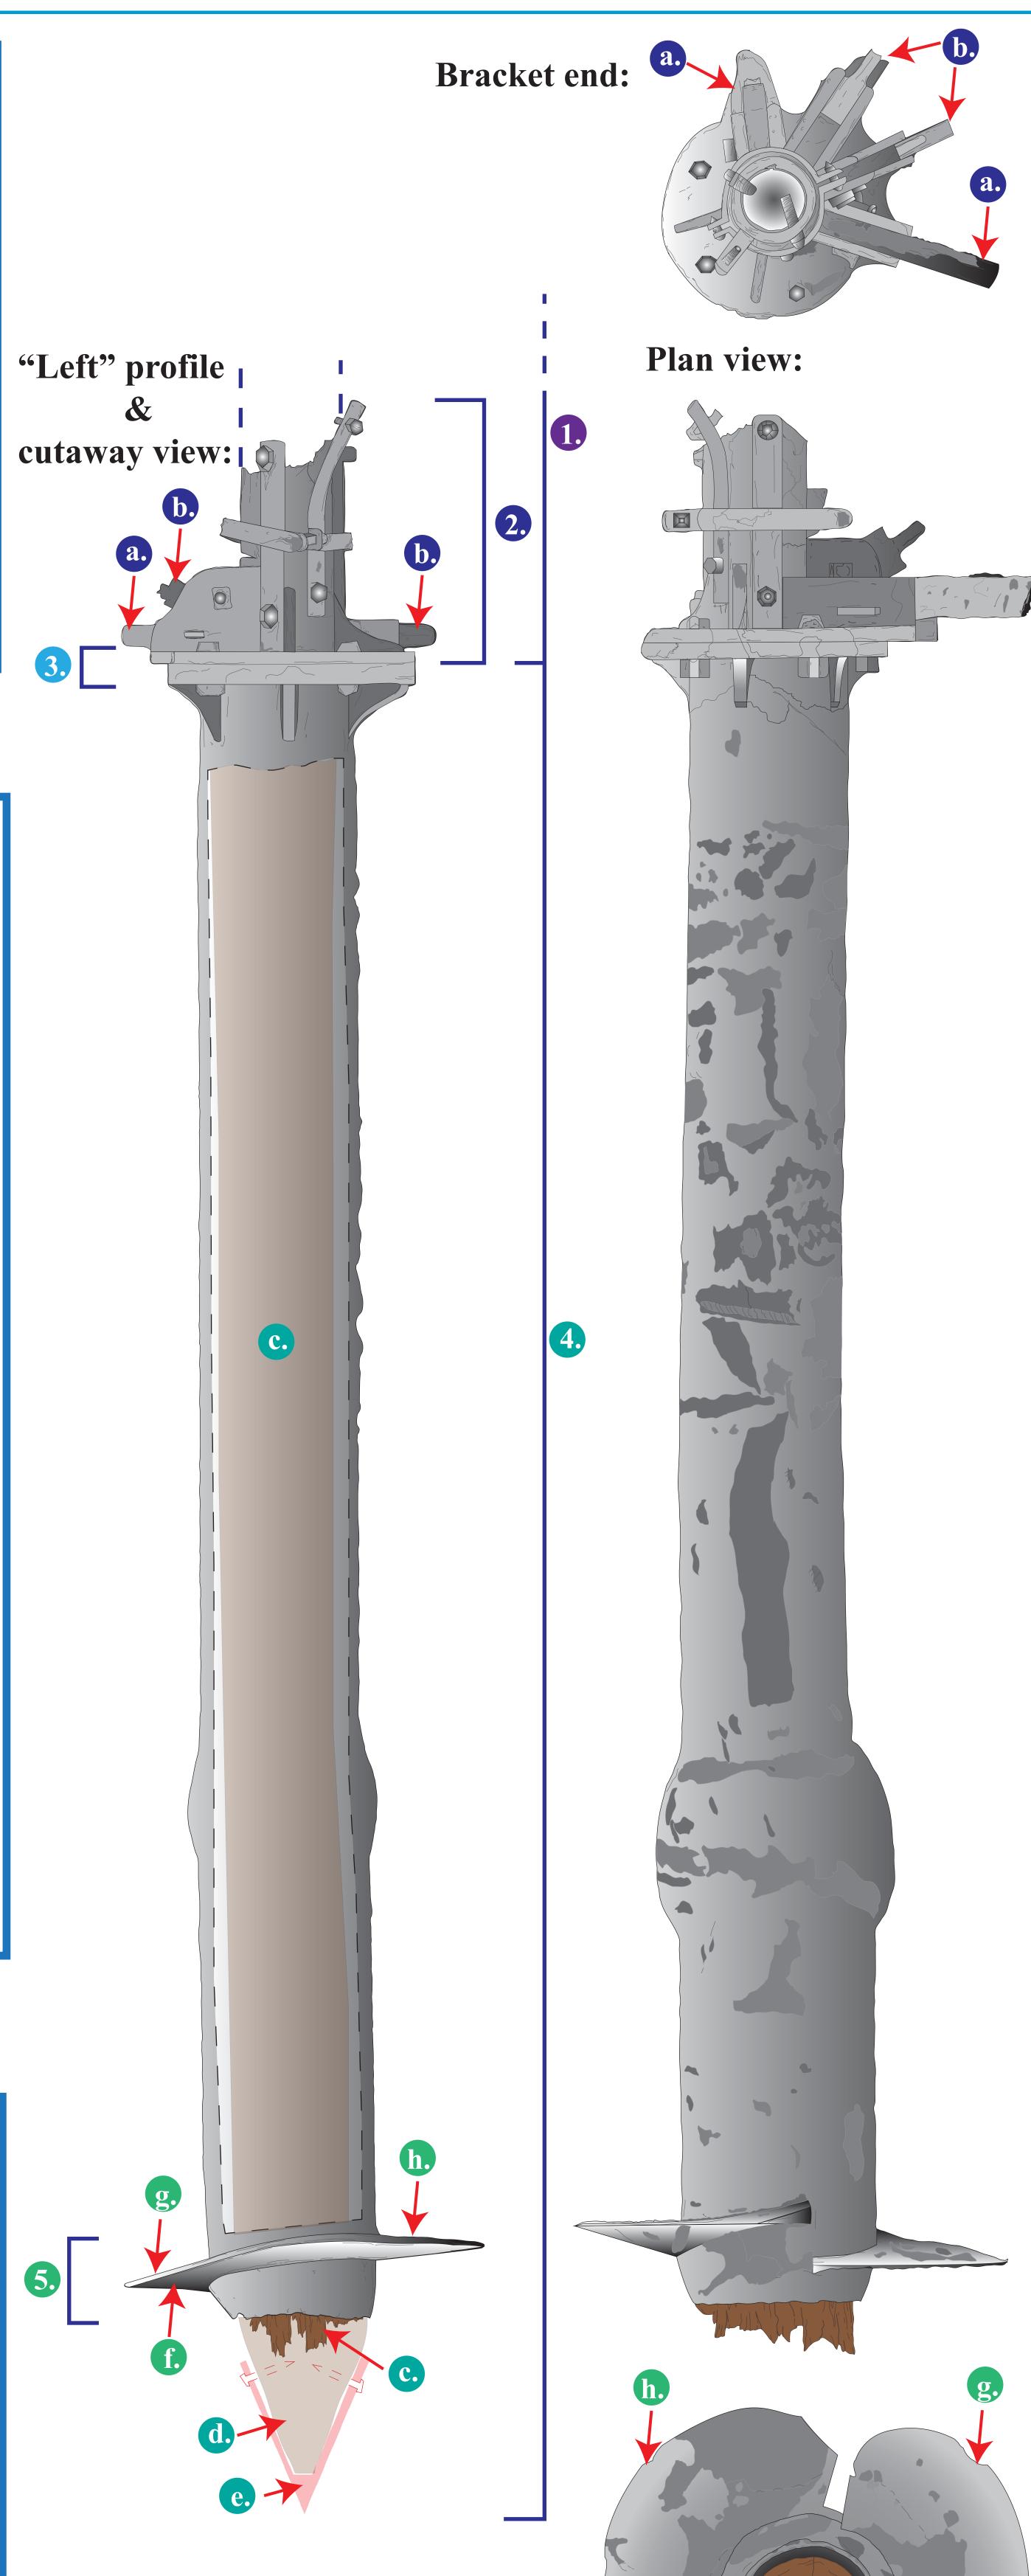
"Light House, Roanoke Marshes," half sectional elevation & half elevation (with annotations) (National Archives)

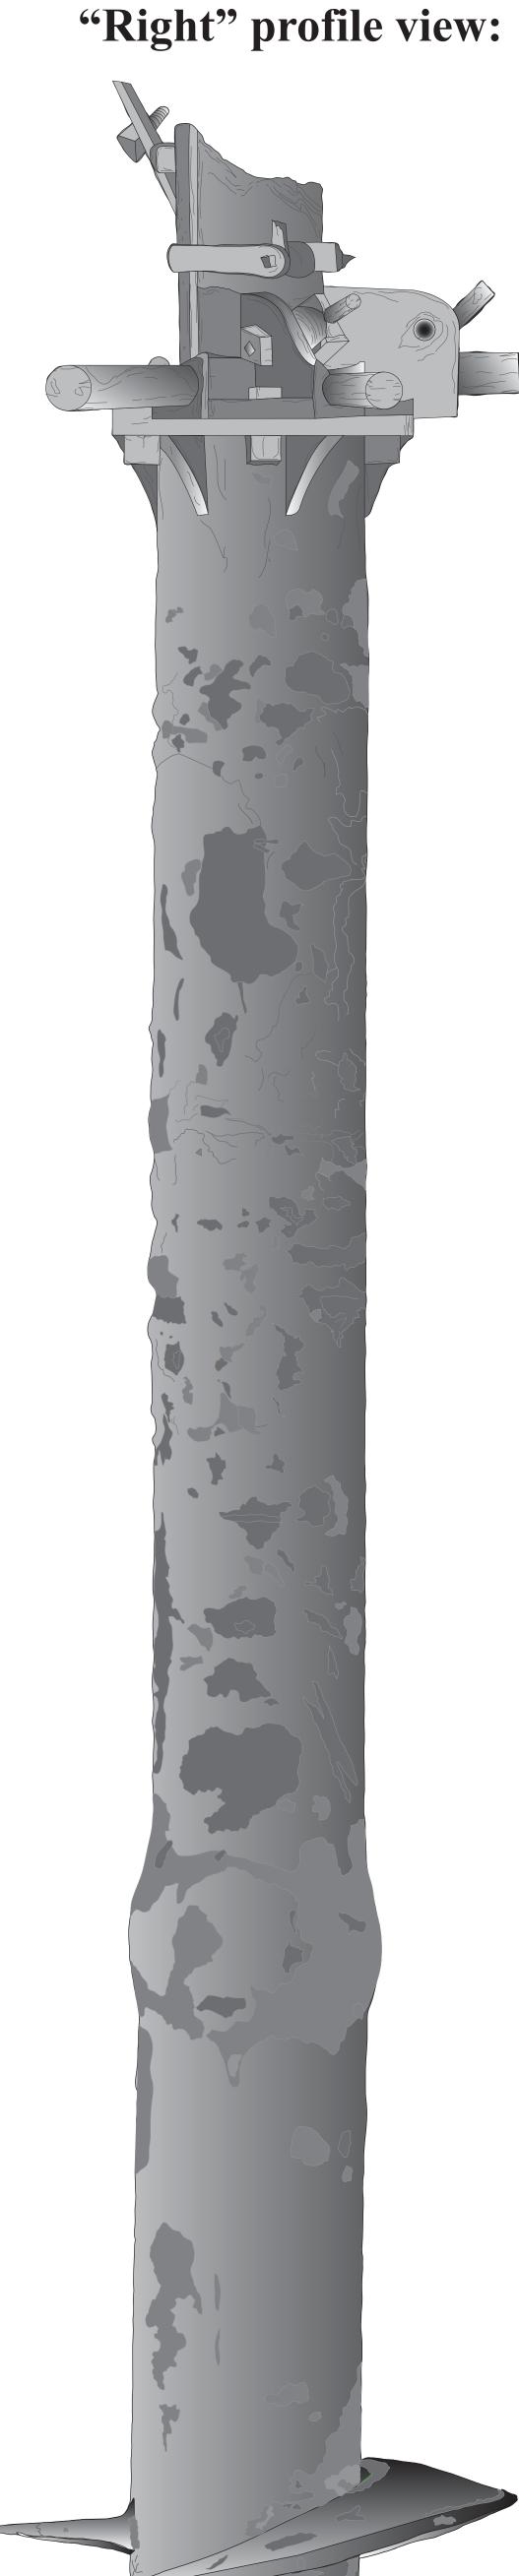
**Guide to Components (top to bottom)** including alternative terminology

- 1. Extension cylinder/shaft/envelope (damaged)
- 2. Bracket
  - a. Horizontal support beams (damaged) b. Tie rods (damaged)
- 3. Coupling
- 4. Lead cylinder/shaft/envelope
- **c.** Wooden stem/pile
- **d.** Wooden stem/pile tip (damaged)
- e. Wooden stem/pile shoe (missing)
- 5. Screw/helix/spiral/flange/worm
  - f. Blade
    - g. Leading edge
    - h. Trailing edge
