**NCPTT 2016-17 Grants**

**Institution/Organization:**  
Program in Maritime Studies, East Carolina University

**Project title:** Coastal Heritage at Risk

## **Abstract**

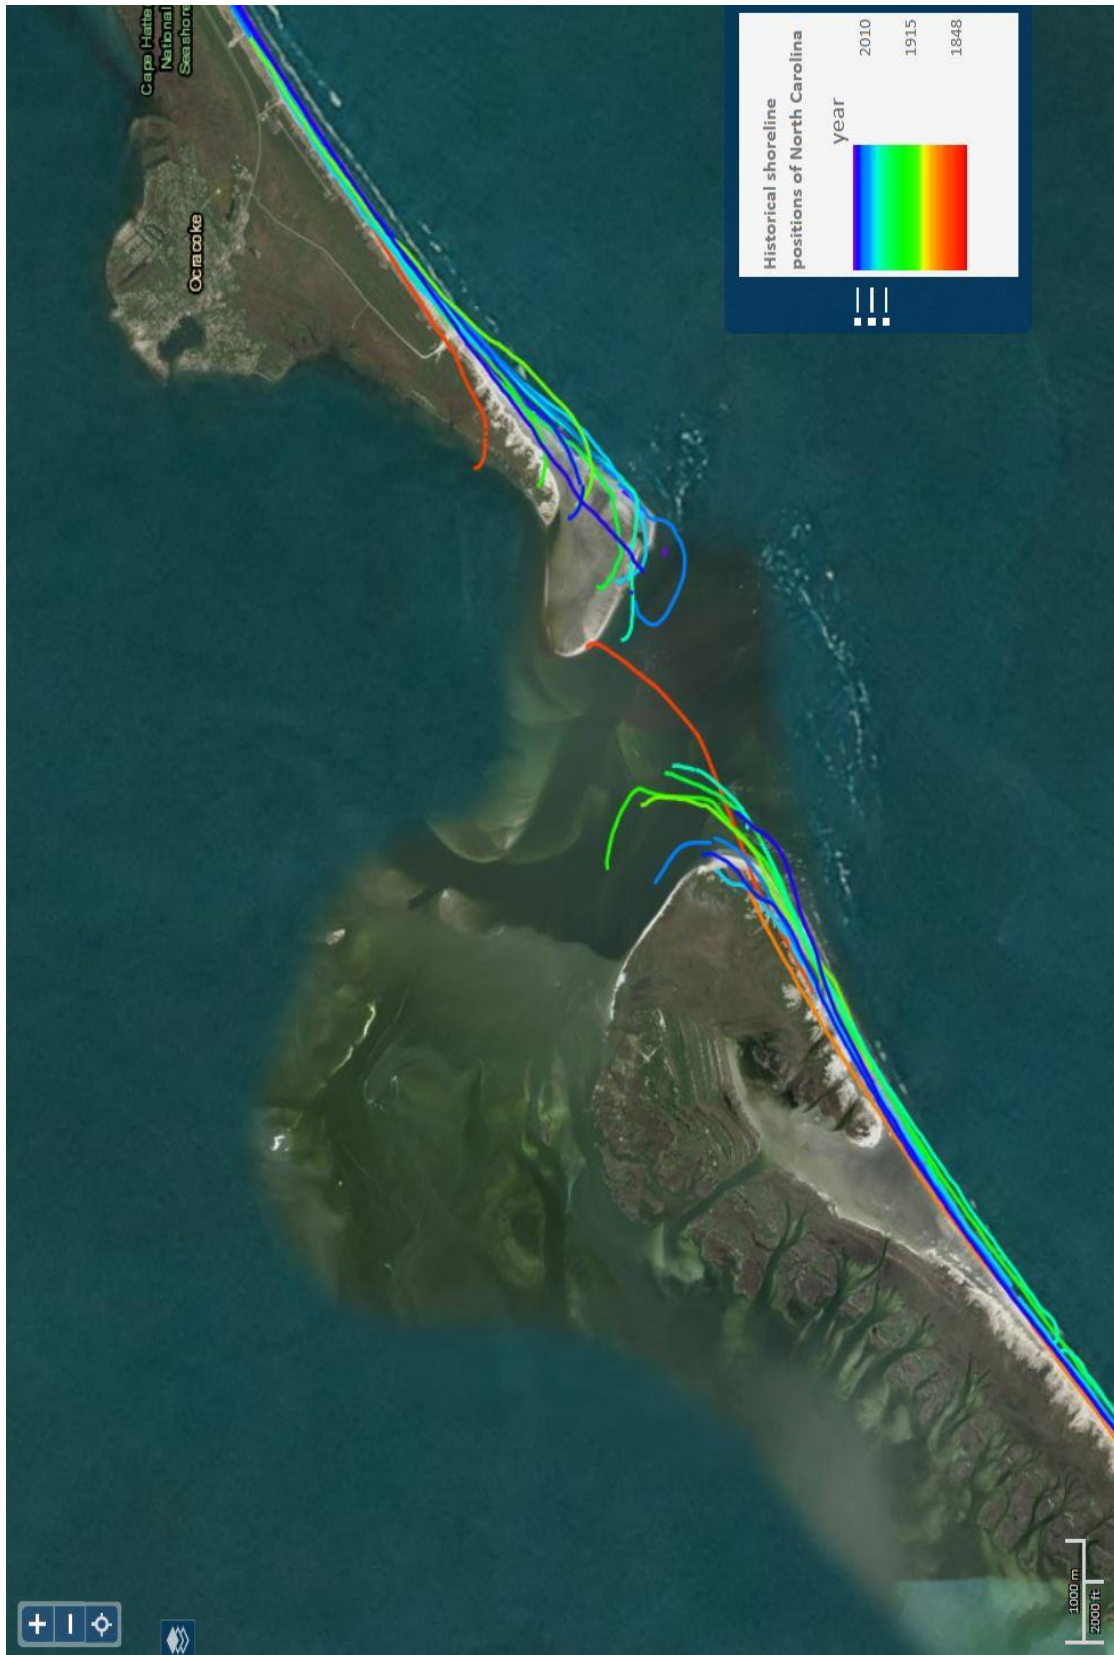
The historic sites at Portsmouth Island occur at low elevations on a dynamic barrier island. Many of the sites occur within 0 to 1.5 m above sea level, meaning they are likely to be inundated by rising seas over the next century (Fig. 20). Thieler and Hammer-Klose (1999) place it in their high to very high risk category. Sediment erosion, transport and deposition in the form of inlet and spit migration, and shoreline erosion and overwash will likely shift the present ocean shoreline to the north, likely further filling the algal flats (Fig. 18), but eroding the sand hills. It is unclear what may happen to the inlet shoreline as it depends on unpredictable storm energy and sediment transport around the inlet, affecting the channel position. If the trend of the last 30 years continues,

Figure 20. Historical shoreline positions since 1848 for the Portsmouth Town to Ocracoke

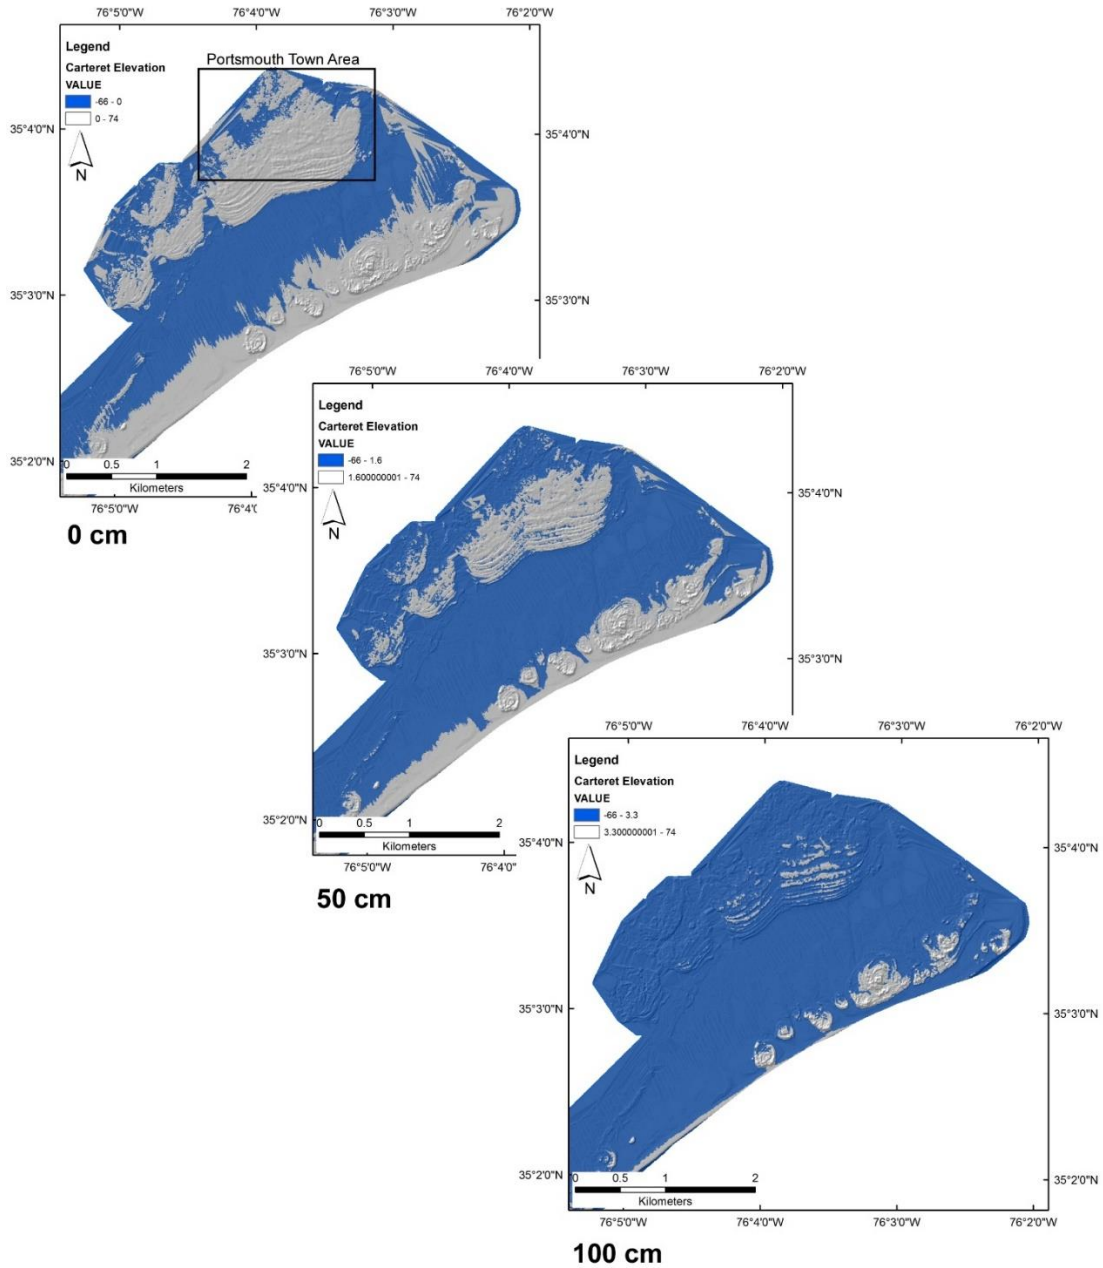
Figure 21. Inundation of Portsmouth Banks (LiDAR data).

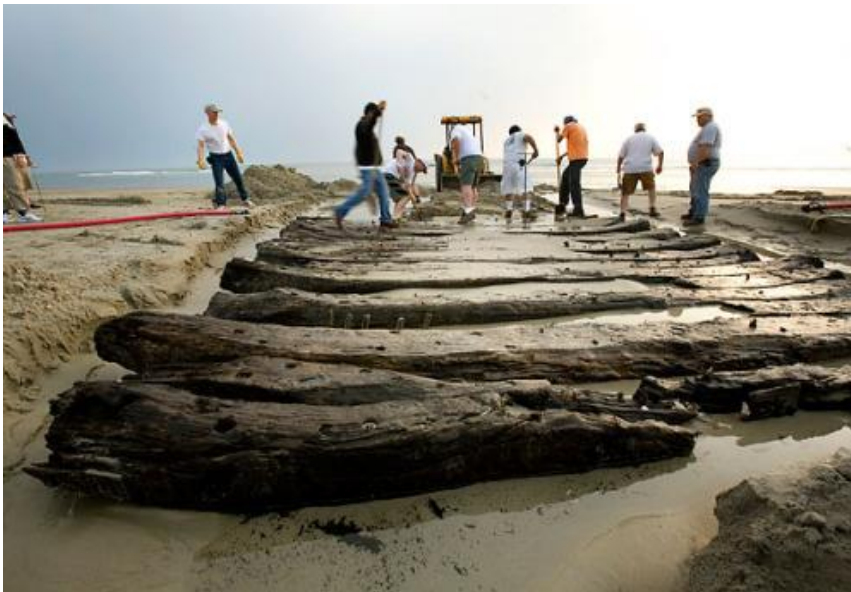
Figure 22. Corolla Shipwreck on the beach

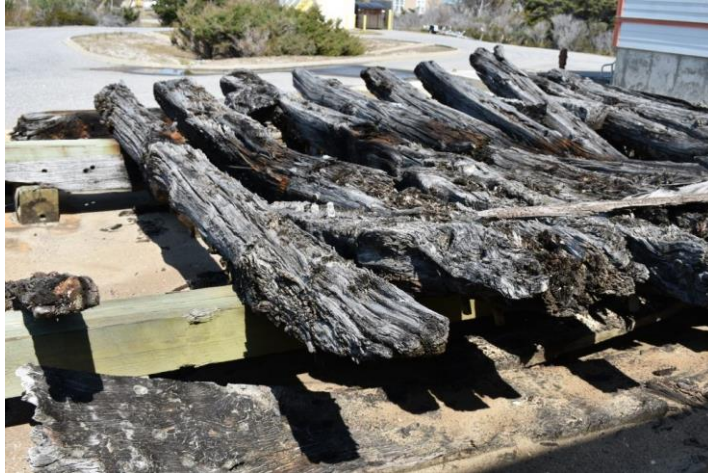
Figure 25. Wreckage elevated on a wooden platform (Photo Credit: Tyler Ball, ECU)

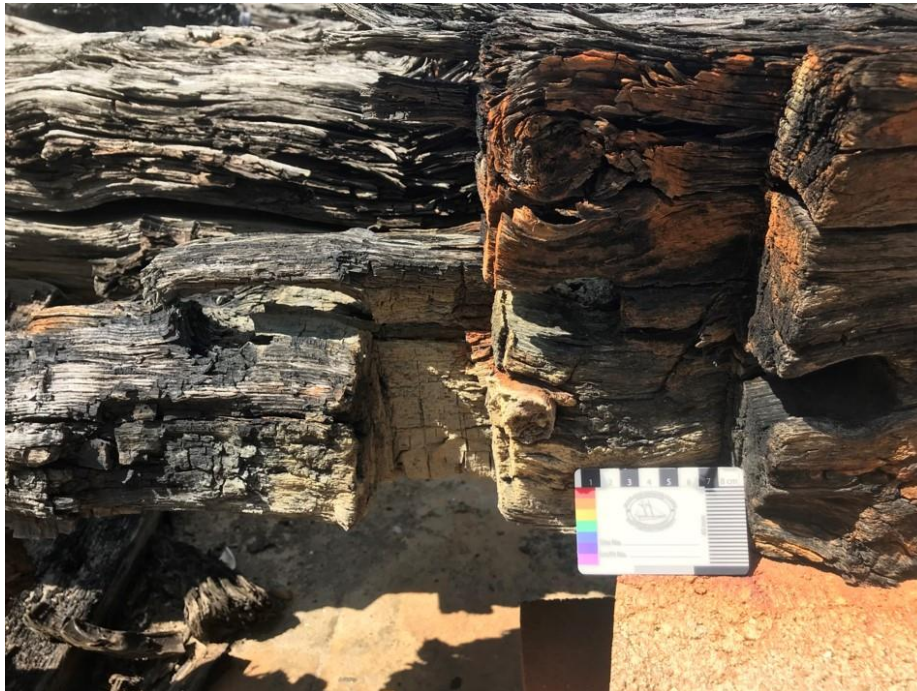
Figure 31. Close up of the Keel notch located on the aft frame. (Photo by Ryan Miranda, ECU)

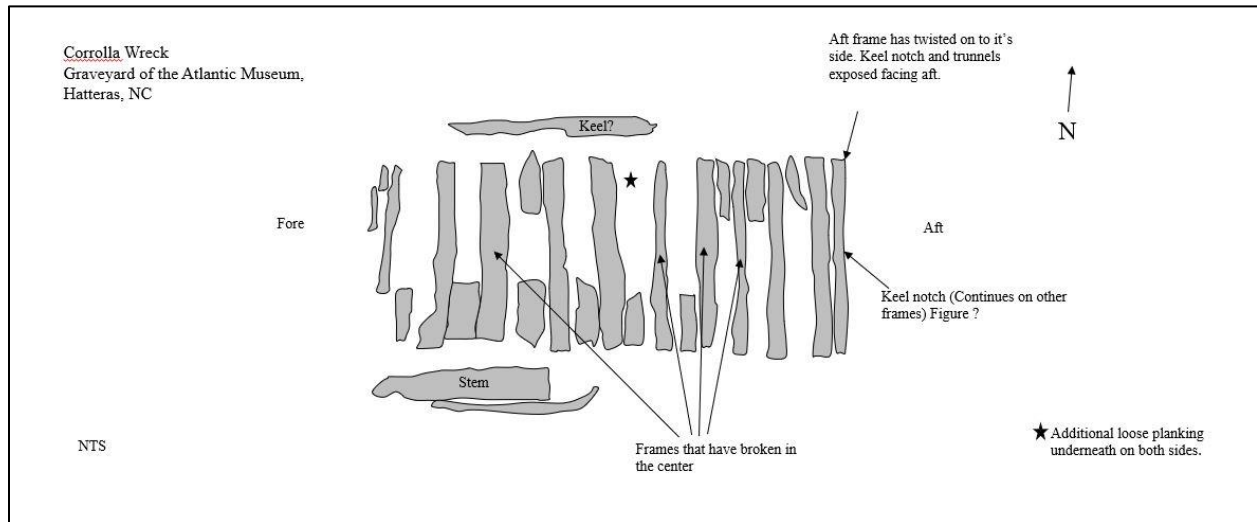
Figure 32. Sketch Map of Corrolla wreck, August 27 2018 (Created by Ryan Miranda, ECU).

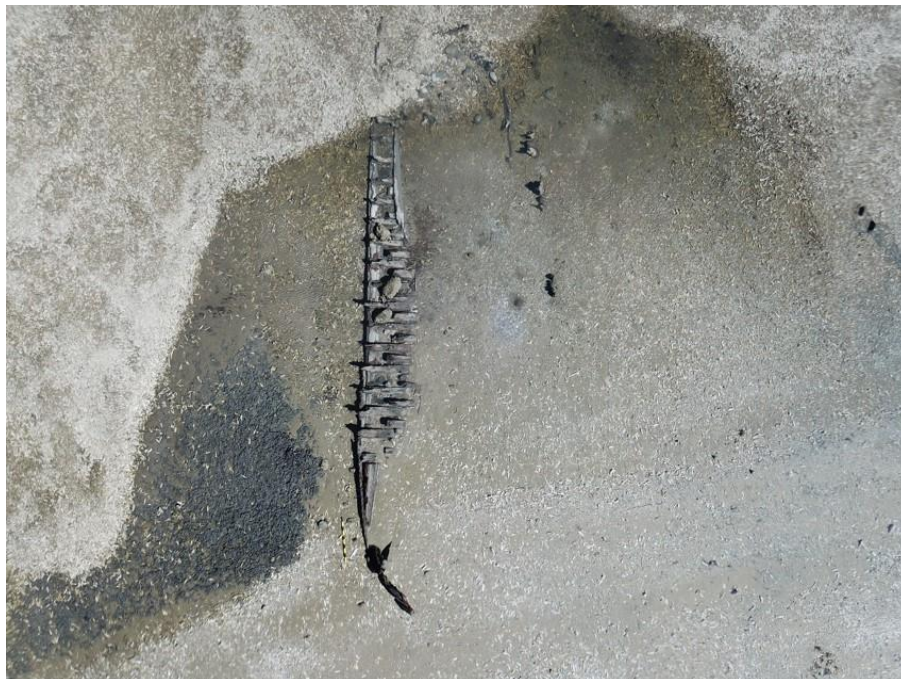
The shipwreck, with an overall length of 13.80m and maximum beam of 4.50m, comprises wood fragments, primarily short sections of 17 framing members around 21cm in width and spaced 31 cm apart. The fastenings included both treenails (wooden dowels) and metal spikes. Other timbers were outer and inner hull planking on the wreckage situated higher up on the beach. The site is orientated diagonally to the water's edge. The team observed teredo worm (*Teredo navalis*, the naval shipworm, is a species of saltwater clam, a marine bivalve mollusc in the family Teredinidae, the shipworms). This species is the type species of the genus *Teredo*. Like other species in this family, this bivalve is called a shipworm, because it resembles a *worm* in general appearance) on a few of timbers, especially the frames.

Figure 33. Plan View of the Hilton Head wreck (Captured by Jeremy Borrelli).

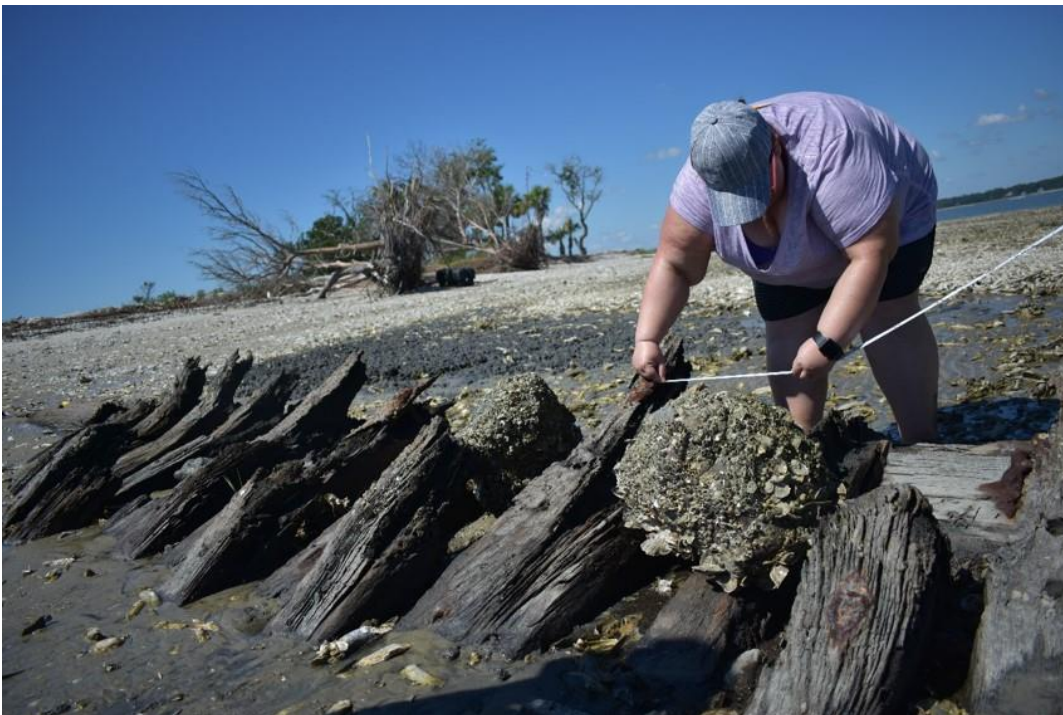
Figure 37. Jennifer Jones recording timber degradation (Photo by Lynn Harris)

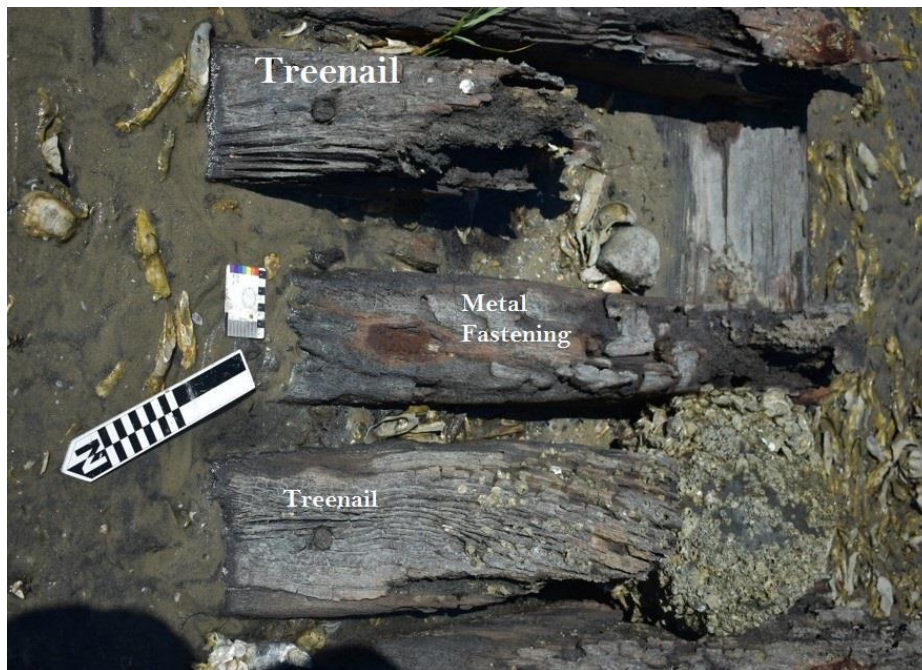
Figure 41. Teredo worm concreted casements in timber (Photo by Jeremy Borrelli).

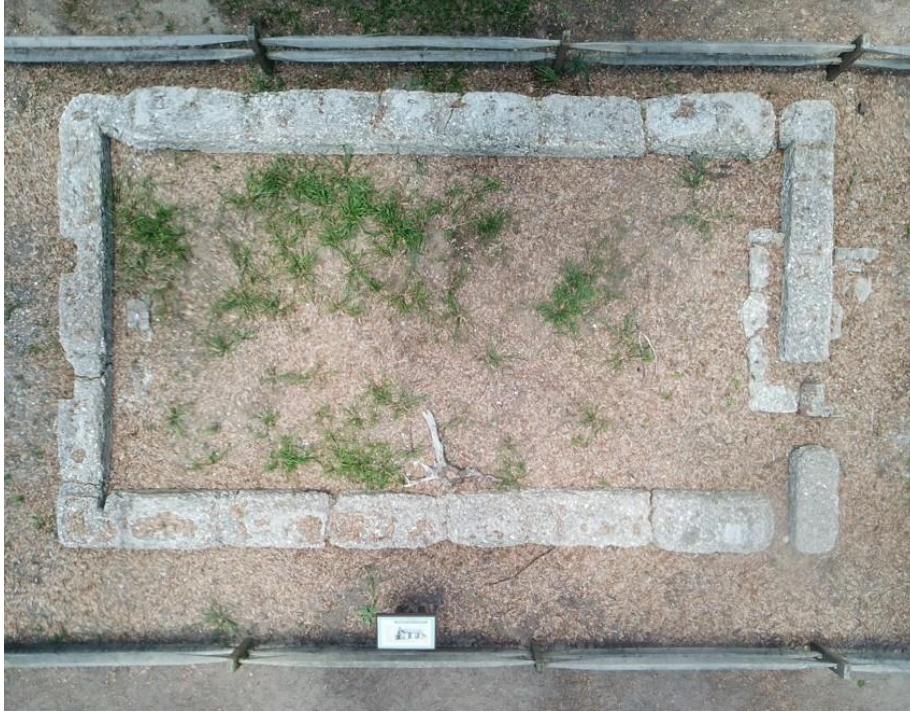
amongst an upscale suburban neighborhood at the far end of Hilton Head Island. The overall structures appear deteriorated, but lack evidence of erosion, as each individual oyster shell from the tabby construction can still be observed- a true testament to the history and influence of this structure to the local area.

Figure 48. Tabby ruins of the Main House (Photo by Jeremy Borrelli).

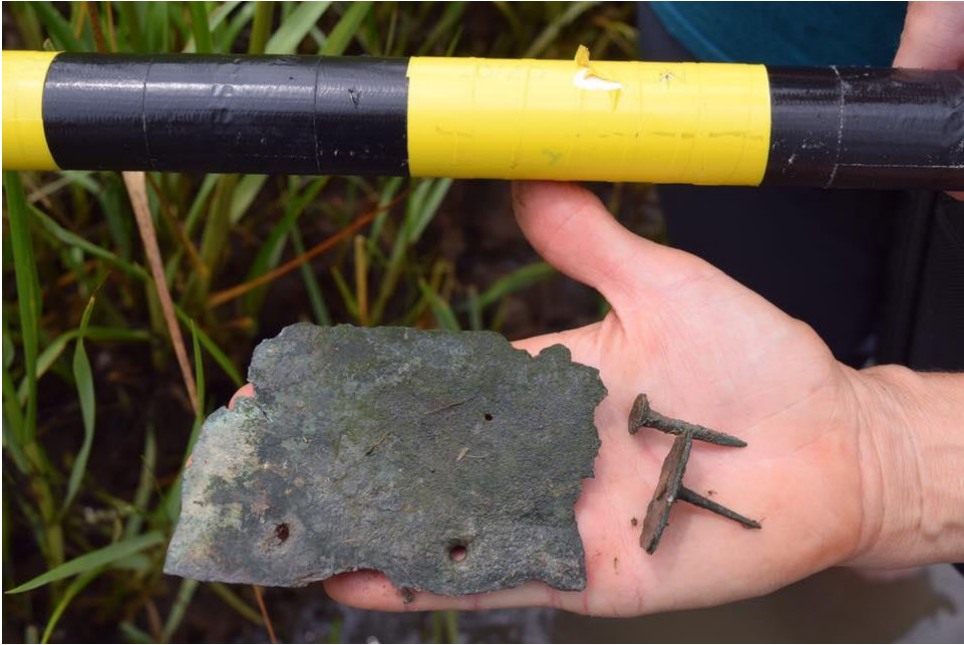
Figure 66. Evidence of edge to edge fastening of the hull planks. This fastener would have likely been near the center of the plank, suggesting the wood has degraded significantly (Photo by Jeremy Borrelli).

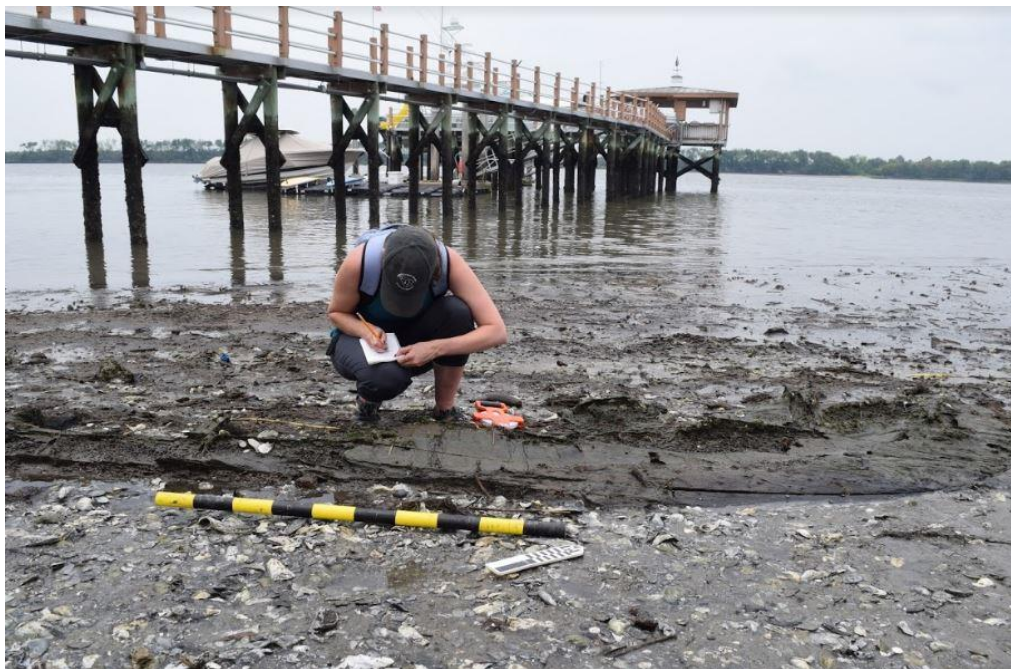
exposed where planks are missing. Fastenings are abundant, especially in the stern area and include copper sheathing tacks and holes for trunnels. The best preserved portion is the stern area (1.32m in width) becoming, with timbers increasingly eroded towards the bow (91cm in width). Evidence of burning is evident in the stern area.

Figure 71. Sheathing tacks and burning on Wando wreck 2 in the stern area (Photo by Lynn Harris).

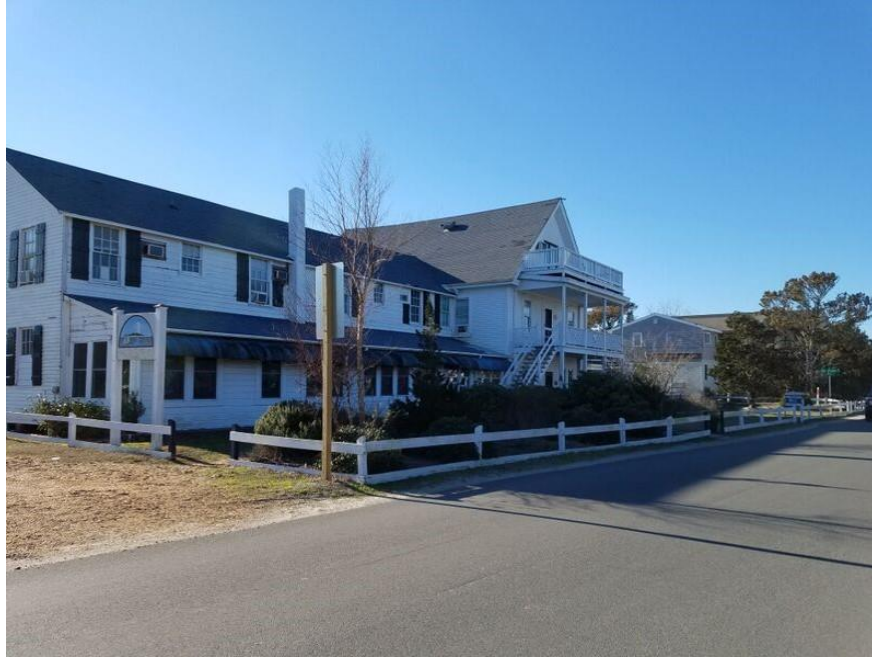
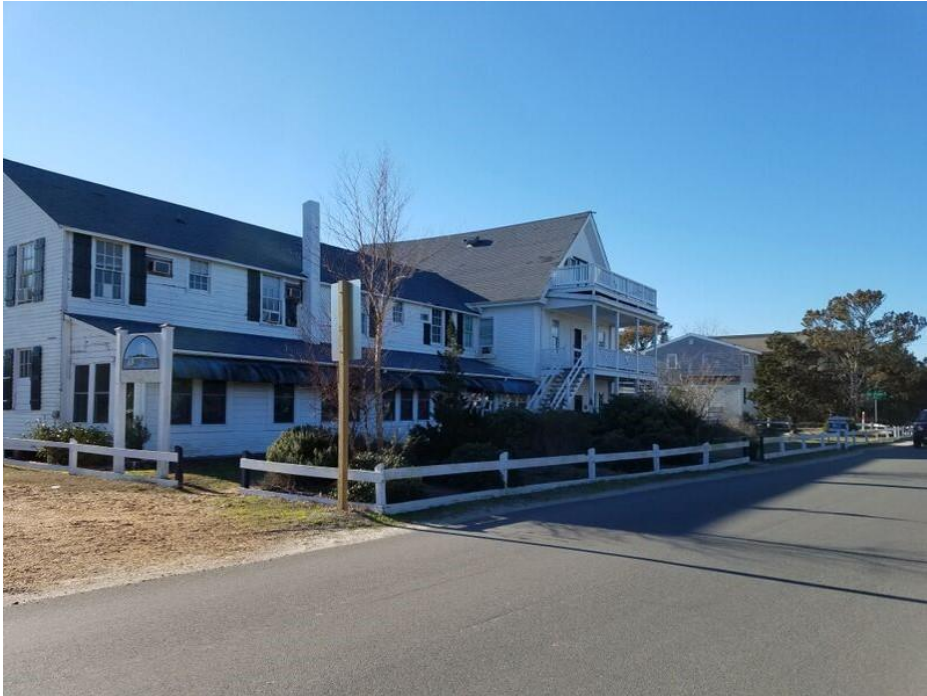
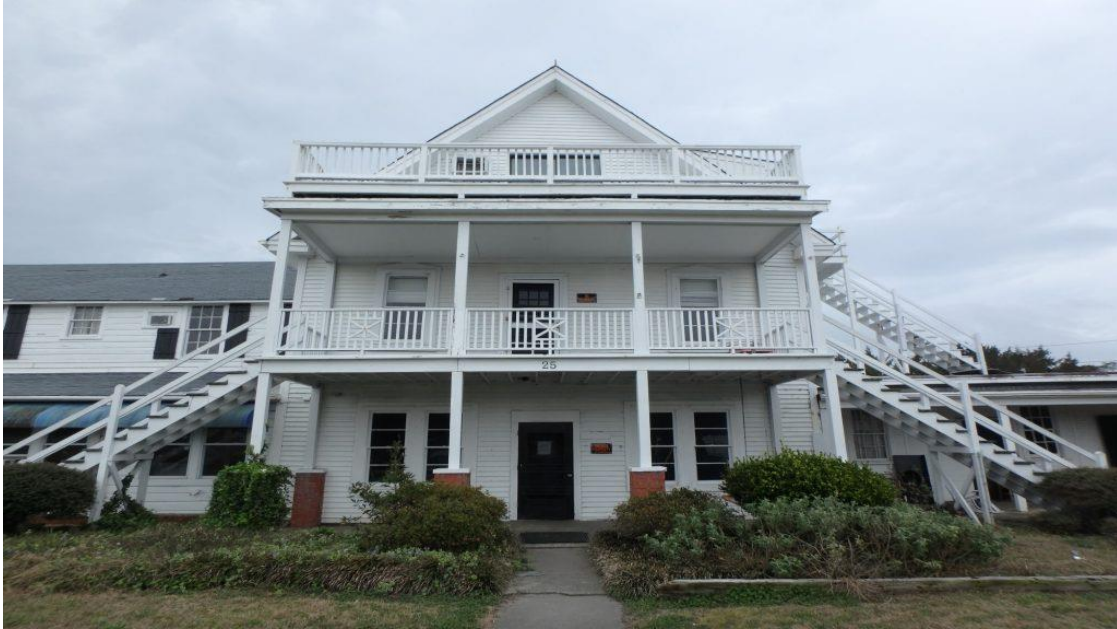
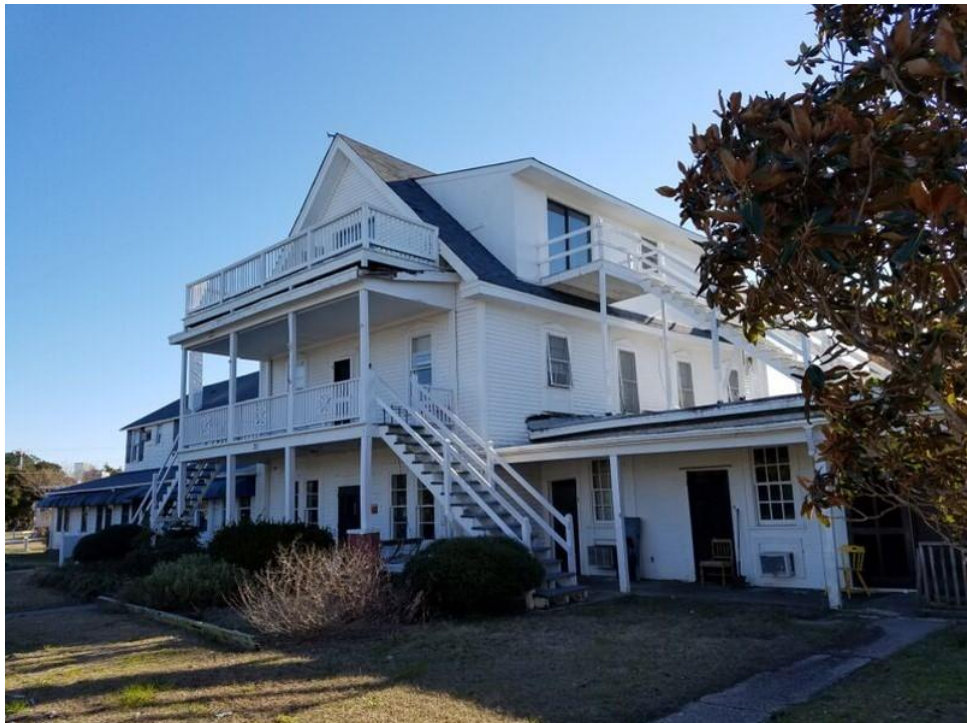
Figure 84. East Side Façade showing stairway to top rooms (Photograph by Lynn Harris, 2017)

Figure 85. West Side Facade View (Photograph by Lynn Harris, 2017)

Figure 86. Front North façade showing room balconies (Photograph by Lynn Harris, 2017)

Figure 87. East Side Façade showing stairway to top rooms (Photograph by Lynn Harris, 2017)

The exterior was assessed with a general rated condition label of fair and poor. The front facade of the building is in fair condition. General weathering has deteriorated the paint on the exterior and removed some of the asphalt shingles from the roof. Some organic staining is present on the exterior as well by the base of the building. While the rest of the front doesn't appear to have any other visible signs of deterioration, the rear southern facade and out buildings have extensive damage and is in poor condition. Figures below depict extensive damage where much of the paint is flaking off down to the wooden substrate. This is most prevalent on the two ells. There is heavy damage to the eastern ell rear where the wall is missing and exposed. It is covered by a blue tarp. Evidence of massive water damage too as there is rot in the wooden walls with heavy organic staining. The various out buildings are in poor to fair shape with many similar issues as explained above. Due to the extensive amount of visible damage, it seems plausible that there is a significant amount of interior damage as well but cannot be determined unless an interior conditions assessment is done.

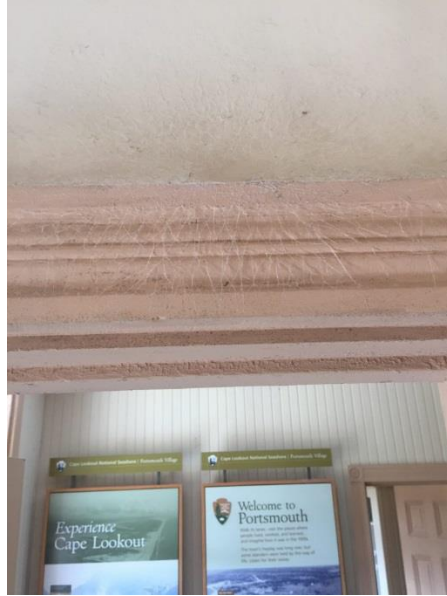
Please note that the entirety of the interior of the building could not be fully assessed as the Life Saving Station Boat Shed, first floor foyer with staircase leading to the second floor, second floor, and observation tower was not examined. The floors, ceiling, and walls were assessed with a general rated condition label of either excellent, good, fair, or poor. Examples of deterioration and related mechanical processes are explained with supporting photographic documentation for evidence of the various types of deterioration. Overall, the general rated conditions of the interior ranges from good, fair and poor with a majority of the rated assessments falling under fair and poor.

Figure 92. Ceiling example in the 1st floor entrance way of the Life Saving Station (Photo by Paul Willard Gates, ECU).

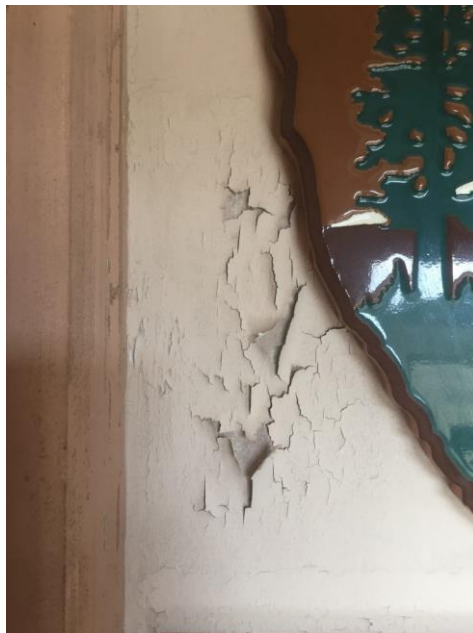
Figure 93. East wall example in the 1st floor entrance way of the Life Saving Station. (Photo by Paul Willard Gates, ECU).

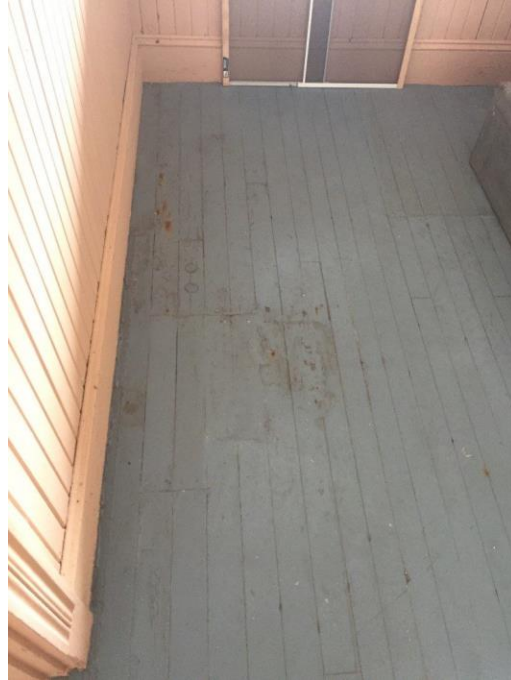
Figure 94. Floor example in the 1st floor pantry of the Life Saving Station. (Photo by Paul Willard Gates, ECU).

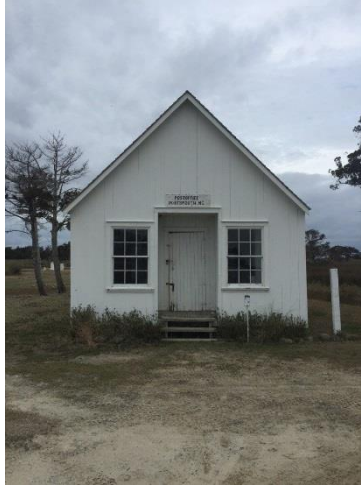
Figure 98. Front of the post office on Portsmouth Island.

Southern Exterior Façade: Good. Some minimal paint damage and loose / missing putty from the muntins holding in the window panes. Further loss of putty will lead to window panes falling out. Some iron staining underneath of paint. Exterior door is offset at a slight angle making it hard to fully close. Similar issues with the interior door. Rust present on the door hinges and handle hardware. General wear and tear on the exterior door and steps. General overall weathering, wear, and tear

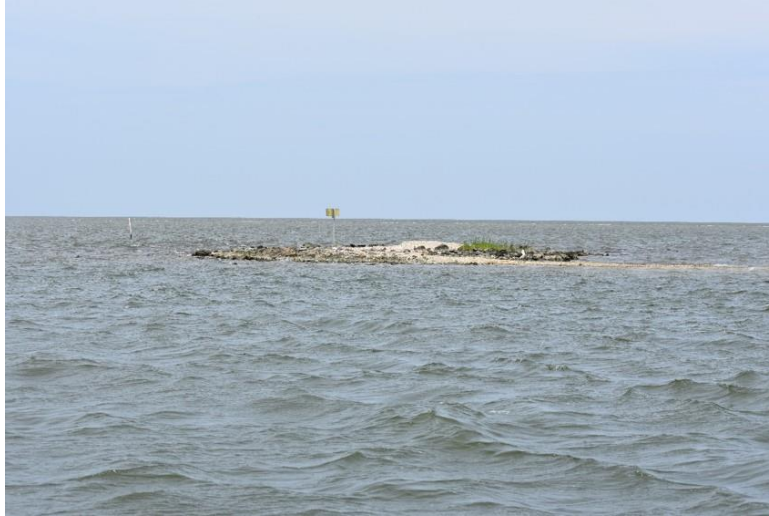
In June 2018 researchers visited the site to see the status of the remaining island steadily washing away and compared it to images 18 years ago.

Figure 107. View of remains of the island in 2018 (Photo by Lynn Harris)

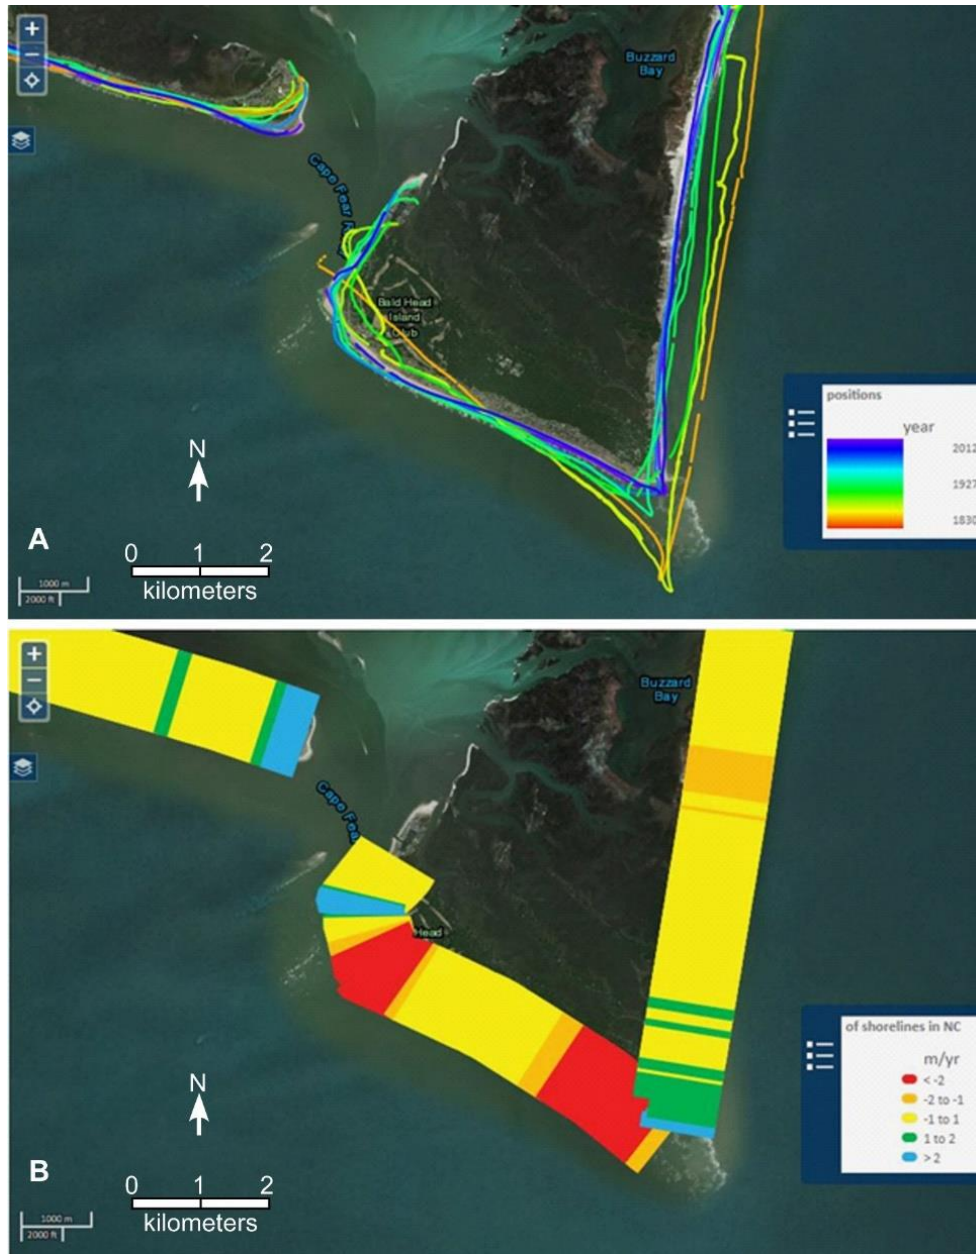
Erosion rates along Bald Head Island vary greatly according to location, with the island shoreline showing a general counterclockwise rotation since 1850 (Fig. 16). Long-term erosion rates are greatest at the western and eastern ends of the island, on the south-facing shoreline. The shoreline near the lighthouse has remained somewhat stable. No data are available for erosion rates on the marsh shoreline north of the lighthouse. A 1300 m long leaky terminal groin structure was recently constructed on the west end of the island to address shoreline erosion where structures were being threatened, and the Village of Bald Head Island (VBHI) regularly receives beach nourishment sand from U.S. Army Corps of Engineer dredging of Wilmington Harbor channel. However, shoreline erosion and loss of sand from the island continues at an estimated 371,700 cubic yards per year (Walsh et al., 2017). The impacts on the shoreline to the east and north of the lighthouse have not been determined.

Figure 111. Shoreline positions since 1830. B) Average erosion rates.

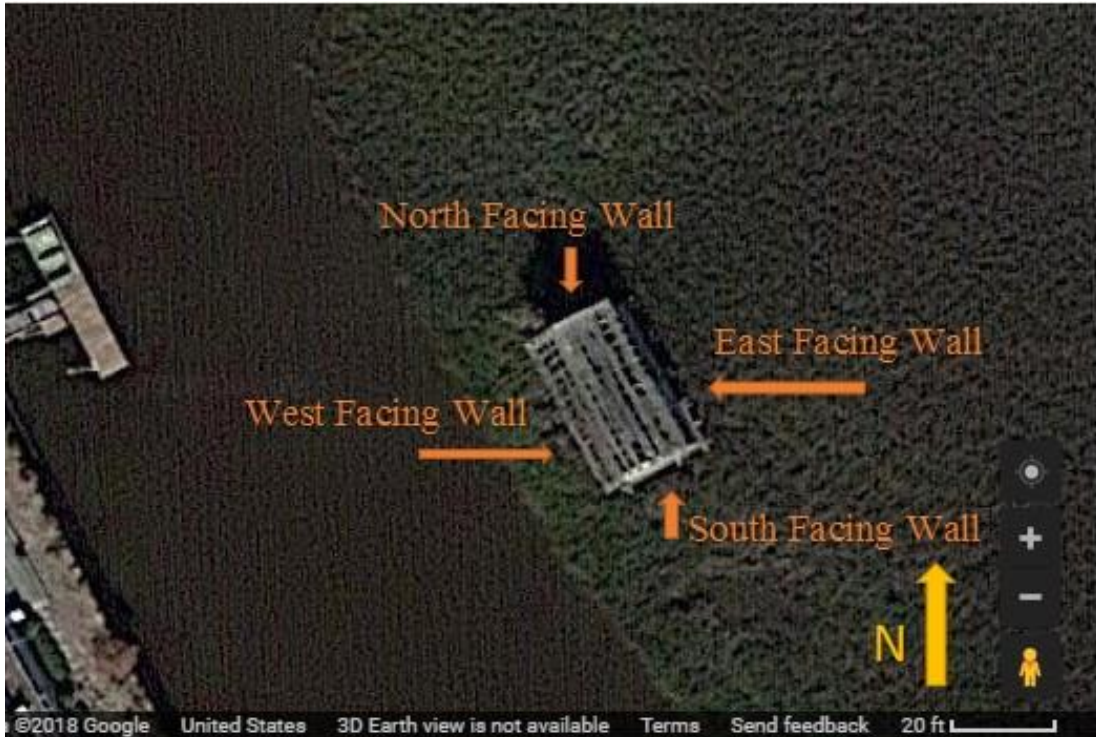
Rapid reconnaissance survey of the heritage-at-risk site Bald Head Creek Boathouse on Bald Head Island, North Carolina. Surveys included detailing the condition and degradation of the Bald Head Creek boathouse, taking photographs and videos of the interior and exterior, and mapping the shoreline of the marsh land that the boathouse is situated upon.

Figure 116. Diagram of Boat house from an aerial view  
(Adapted from Google Earth by Tyler Ball, ECU).

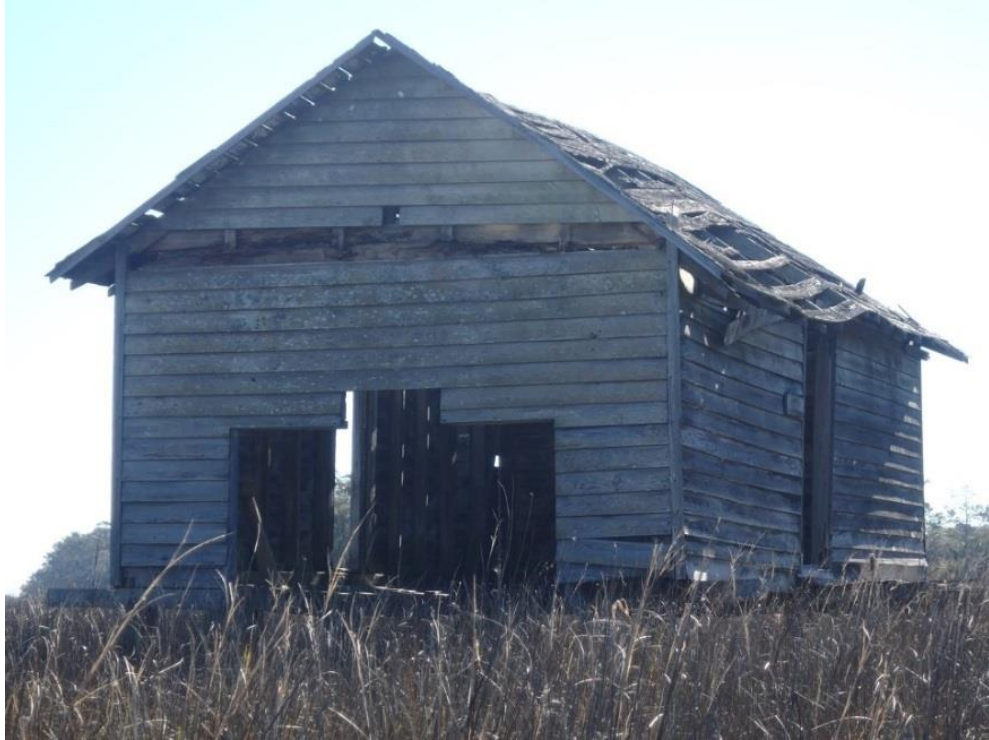
Figure 117. South and west face of boat house (Photo by Aleck Tan, ECU)

Lapstrake siding (16 total cedar planks) are intact for the most part, slightly warped and weather-worn. Small degradation on southern side, but otherwise in fairly good condition. There is a 2-3 foot stoop that runs along the outside of this wall, enough to stand on, but does not extend around the corner to the southern wall, nor does it extend up to the northern wall completely. A door (~3'x6') is cut into the side of this wall, but no door is attached; however, the door frame and one hinge is still intact.

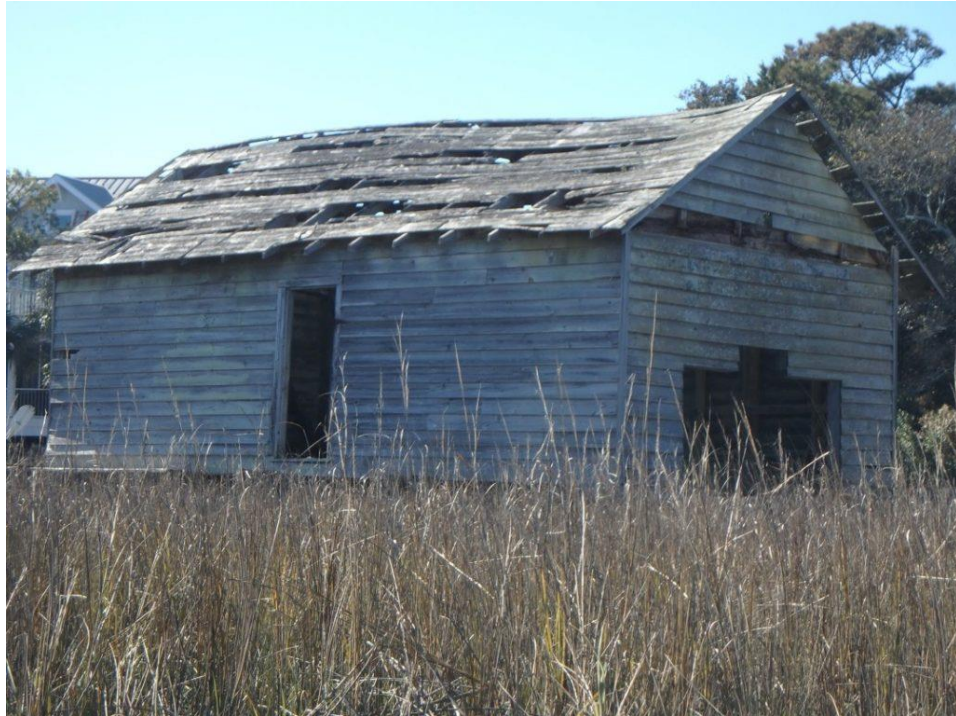
Figure 118. North face view of the boat house (Photo by Tyler Ball, ECU).

This wall's primary feature is the boat entrance; it would be considered a "slip entry" cut out from the lapstrake siding. The wall has some warping along the bottom. The siding is weathered; the top half (above the door) is in poor condition with several pieces either degrading or completely missing. A single siding board is falling off near the bottom right (western) corner.

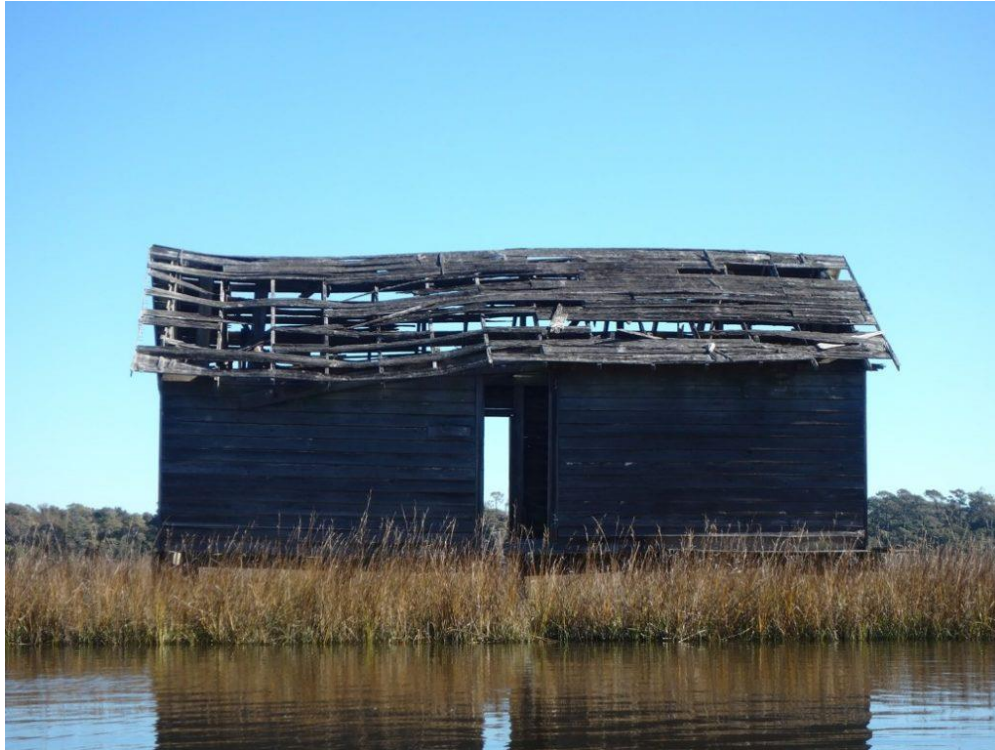
Figure 119. East face of boat house (Photo by Ryan Marr, ECU)

There are 16 total cedar planks on this wall. The wall is in great condition; the siding is weathered but intact. The door frame is intact, and there is an old placard hanging next to the door on the left (north). There are two hinges still on the doorframe.

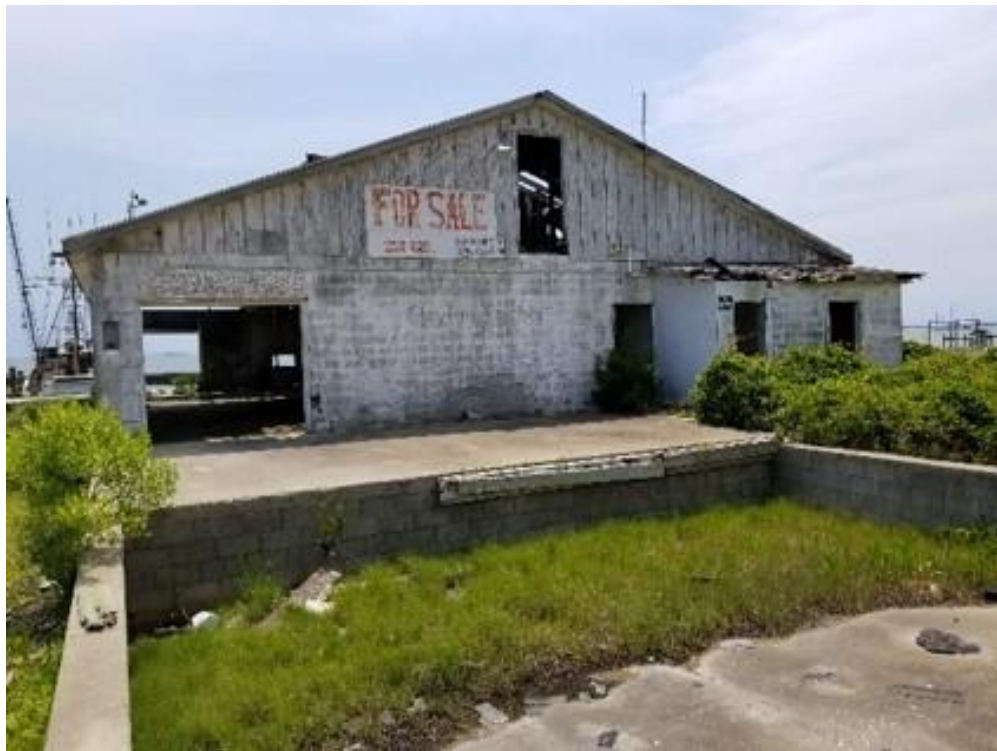
Figure 124. Front entrance of the dilapidated Old Fulcher fish house in Harker’s Island built in 1940s (Photo by Lynn Harris, ECU).

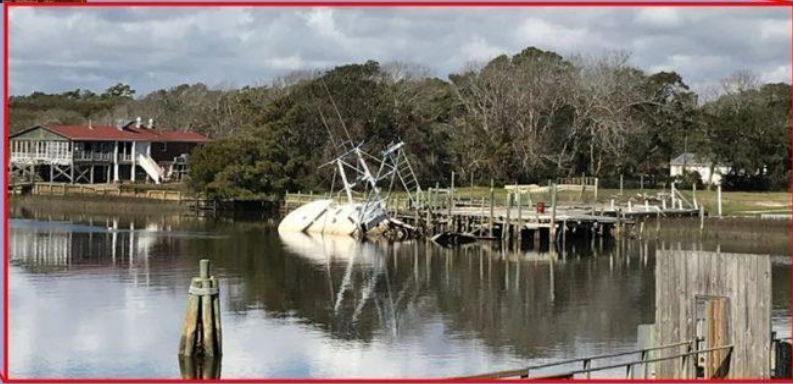
Shrimp boat hulk at FM 1 Holden Beach (Photos by Tyler Ball, Aleck Tan and Molly Trivelpiece, ECU).

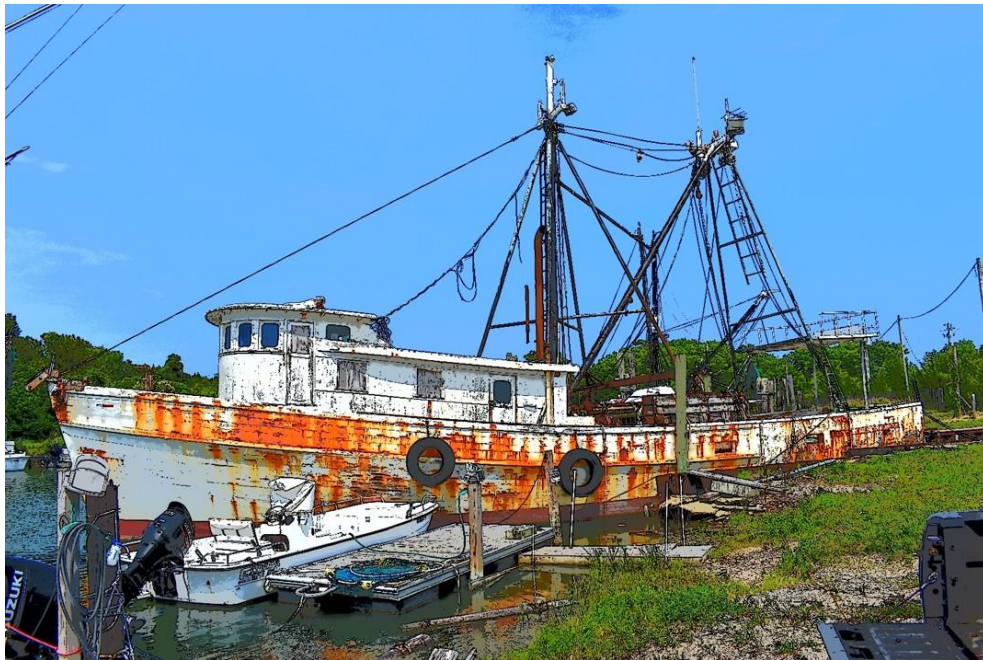
Figure 151. Derelict locally-built 70-foot shrimp fishing boat *Lady Barbara* profile view (Photo by Lynn Harris, ECU).

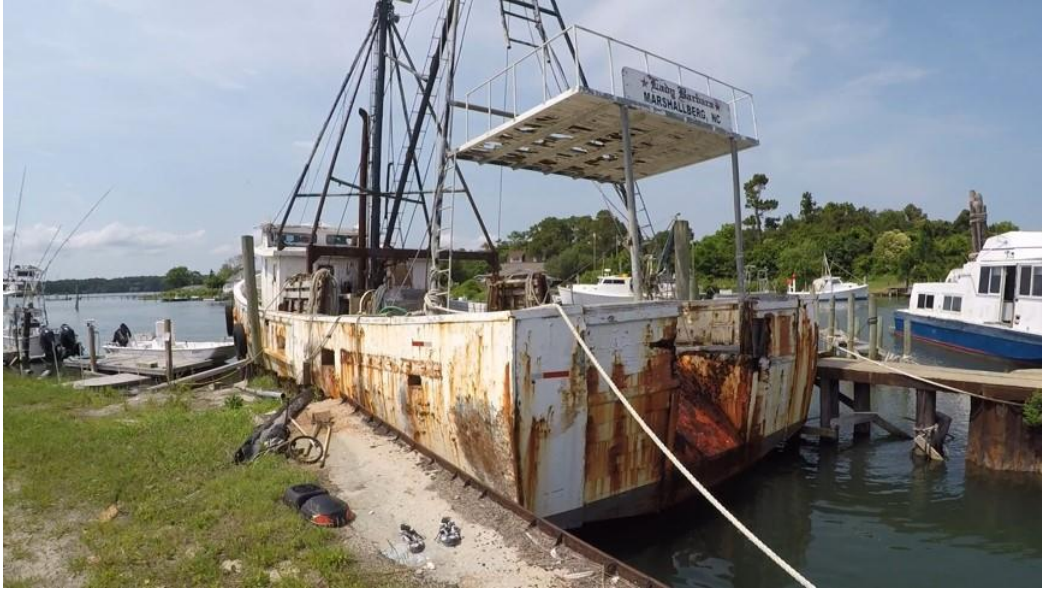
Figure 152. Derelict 70-foot locally-built shrimp fishing boat *Lady Barbara* stern view (Photo by Lynn Harris, ECU).
