**NCPTT 2016-17 Grants**

**Institution/Organization:**  
Program in Maritime Studies, East Carolina University

**Project title:** Coastal Heritage at Risk

## **Abstract**

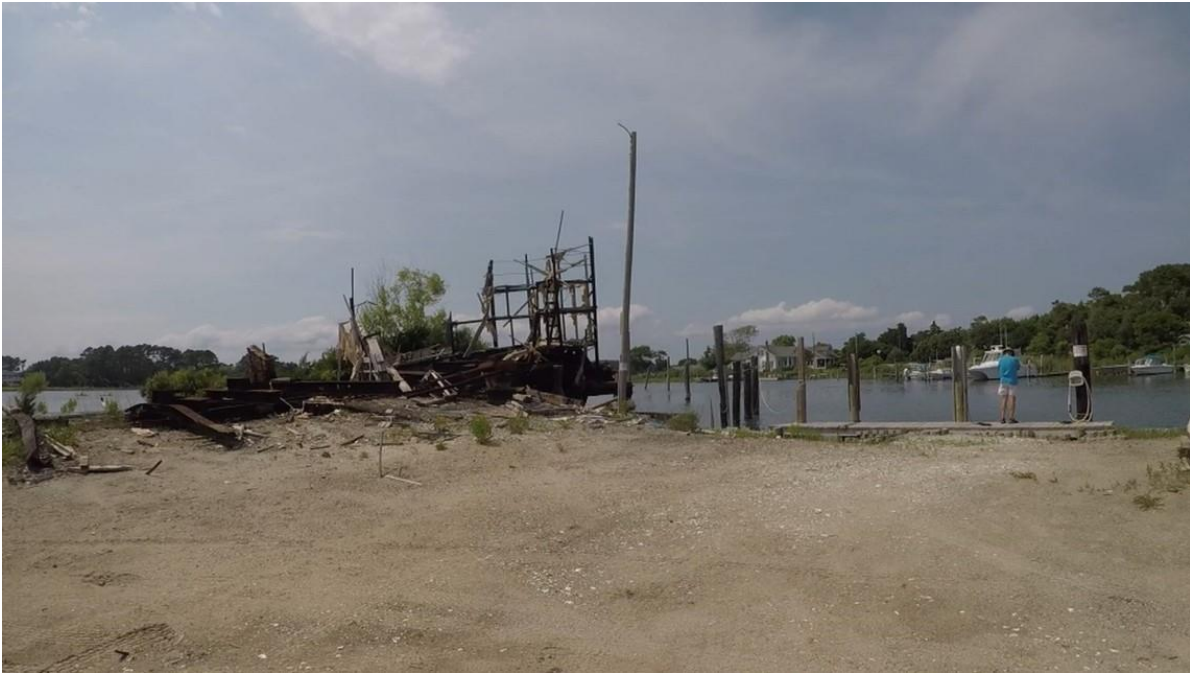
Figure 153. Abandoned dry dock boat lift apparatus (Photo by Lynn Harris, ECU).

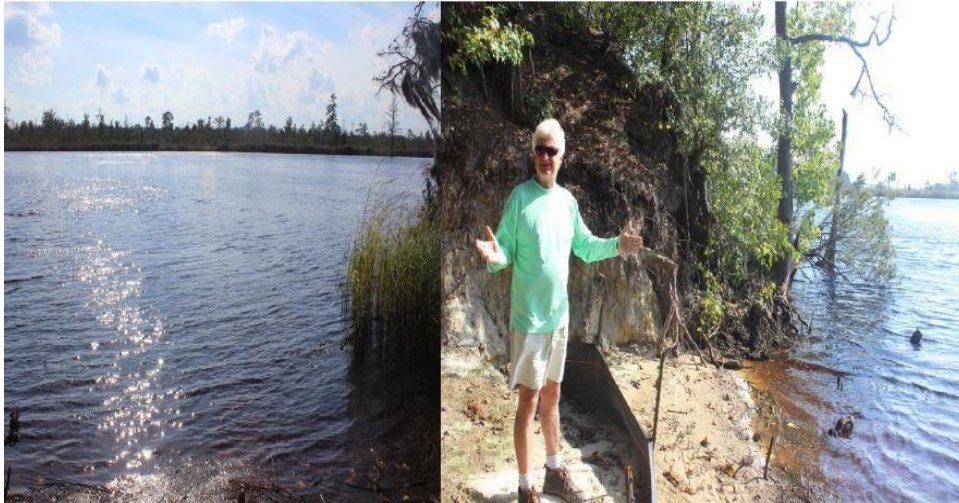
Figure 155. Boat Ramp in progress that may impact the shipwreck site with boat traffic and wake  
(Photo Lynn Harris)

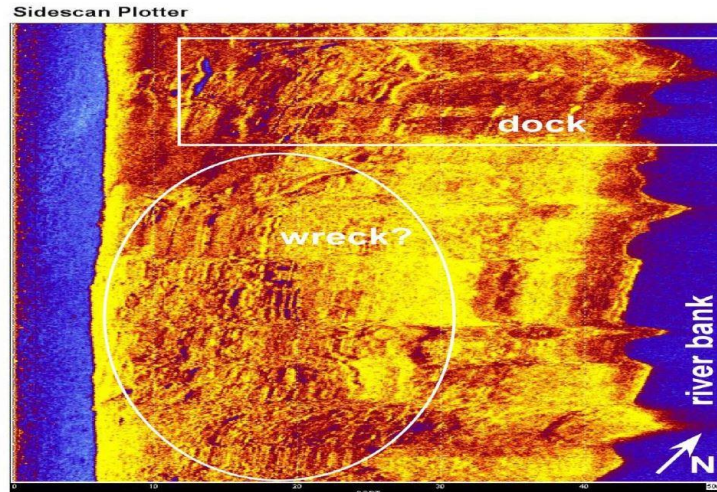
Figure 156. Side Scan image of the wreck and dock (Image by David Mallinson).

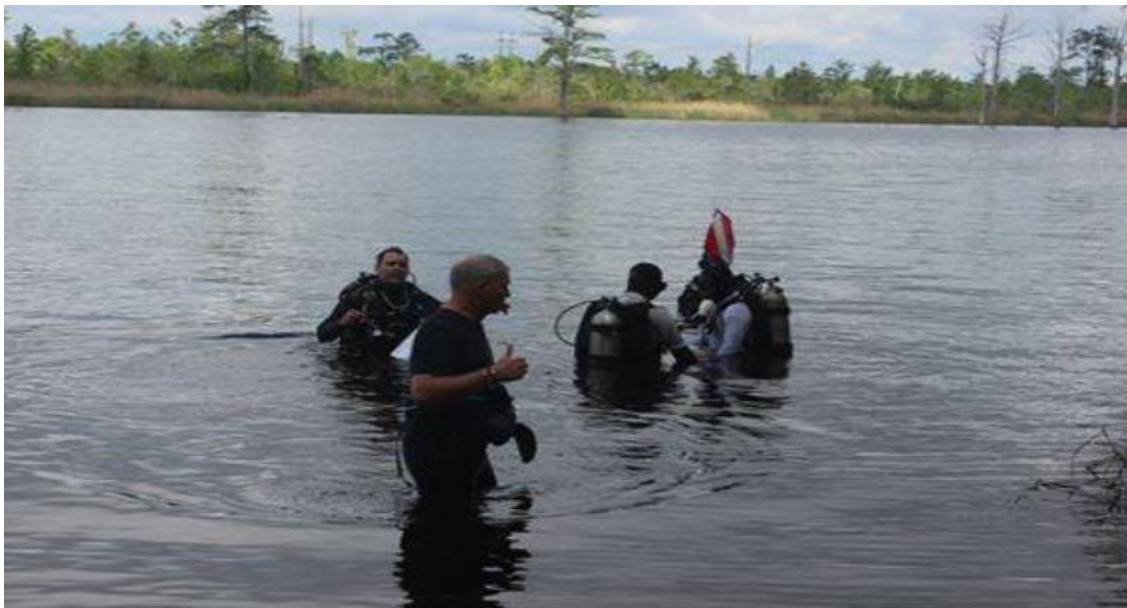
Figure 159. History Department Dive team works with NC UAB to relocate the Rosehill shipwreck and to give a status report on the condition of the hull structure (photo by Lynn Harris).

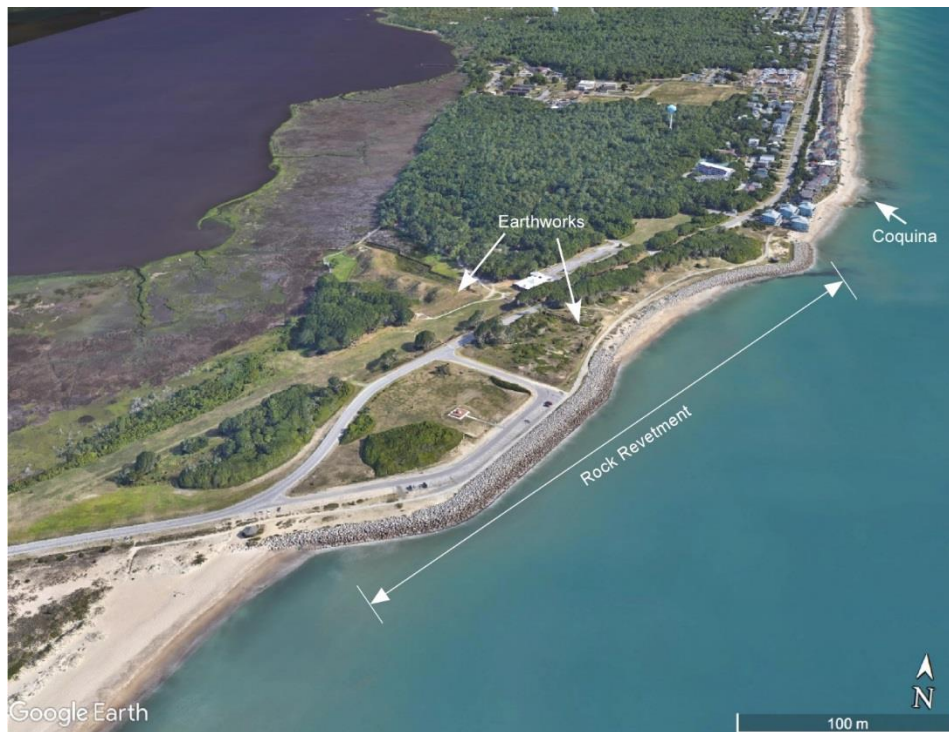
The earthen fortifications of Fort Fisher have suffered due proximity to the Atlantic shoreline. Beachfront erosion destroyed most of the fort by the 1950s. Fortunately, this tidal erosion was arrested in 1996 with installation of a stone revetment wall. However, the erosion caused by wind and rain continues to damage the remaining earthworks. The ground cover is inadequate for preservation, and past maintenance practices emphasizing curb appeal have been detrimental. Without appropriate ground cover and a proper maintenance plan, erosion will continue to adversely impact the remnants of the fort

Figure 180. Oblique view of Fort Fisher showing the remaining earthworks, coquina cropping out on the shore face, and the extensive rock revetment emplaced to protect the historic site.

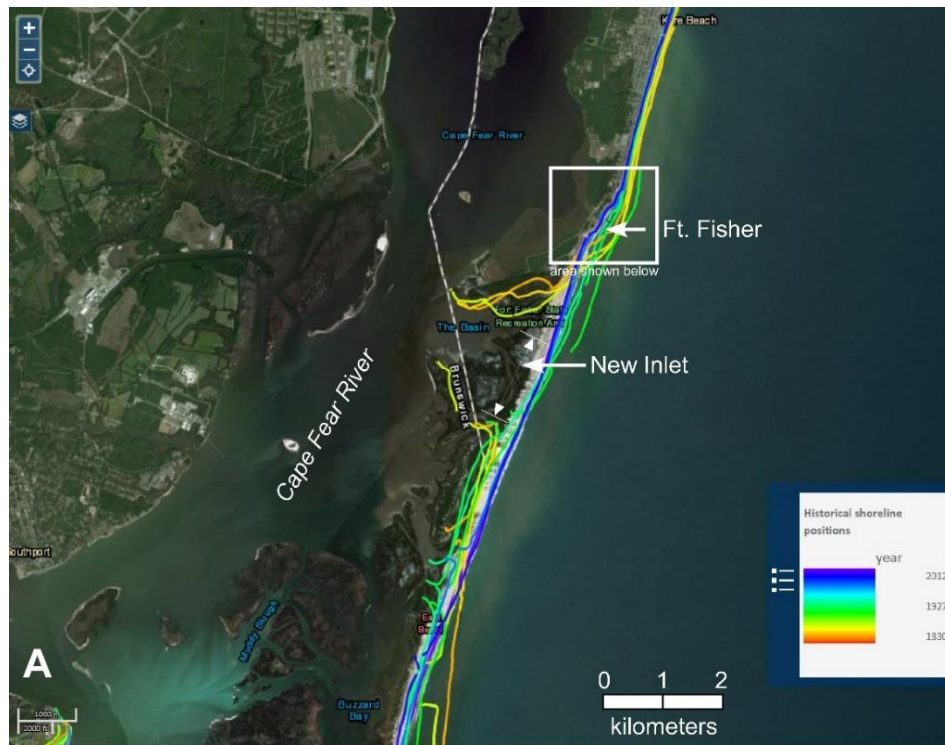
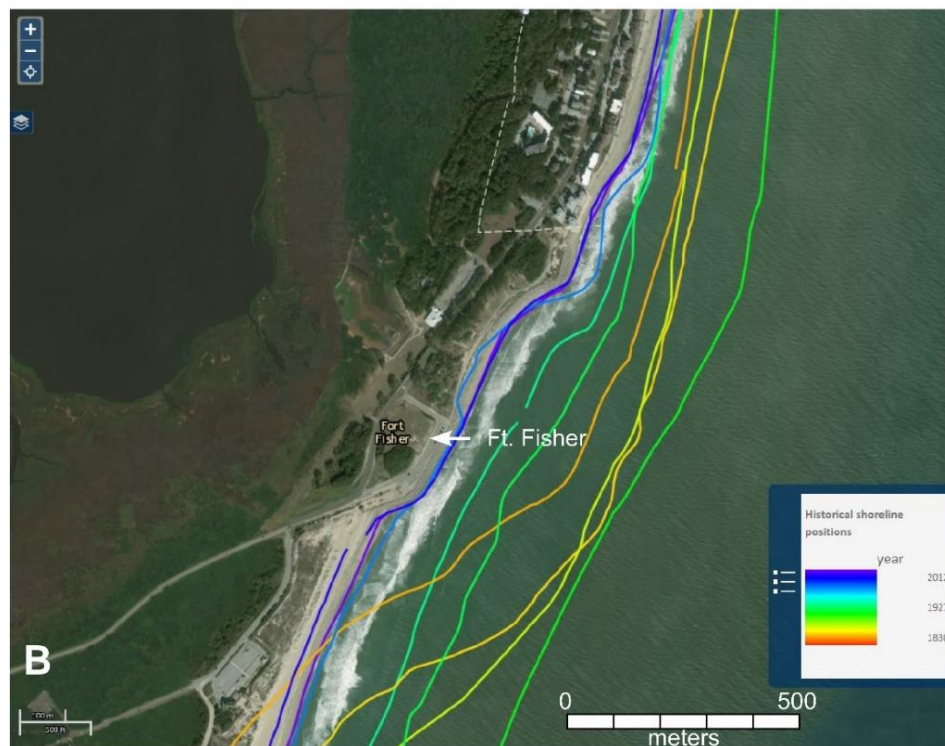
Shoreline erosion in this area has been impacted by the various construction projects, and mining of coquina. Building the “The Rocks” to close down New Inlet resulted in the collapse of the ebb-tidal delta, which was protecting Fort Fisher from wave energy from the south. Also, mining of coquina for building and road construction in the early 1900s accelerated erosion. Several small-scale construction projects including groins and a small rock revetment were undertaken between 1959 and 1970, with boulders dumped continuously along the shoreline from 1970 to 1995. In 1996 a major rock revetment (3,040 feet in length by 70 feet wide) using 3-ton granite boulders and 5-ton interlocking pods was completed. This revetment has, for the time being, stabilized the portion of the coast in front of Fort Fisher, however adjacent areas continue to erode at rates of ca 2 m/y (Fig. 6B).

Figure 183. A). Historical shoreline positions (1850 to present). B). Historical shoreline positions from 1850 to present at Fort Fisher (<https://marine.usgs.gov/coastalchangehazardsportal/>).

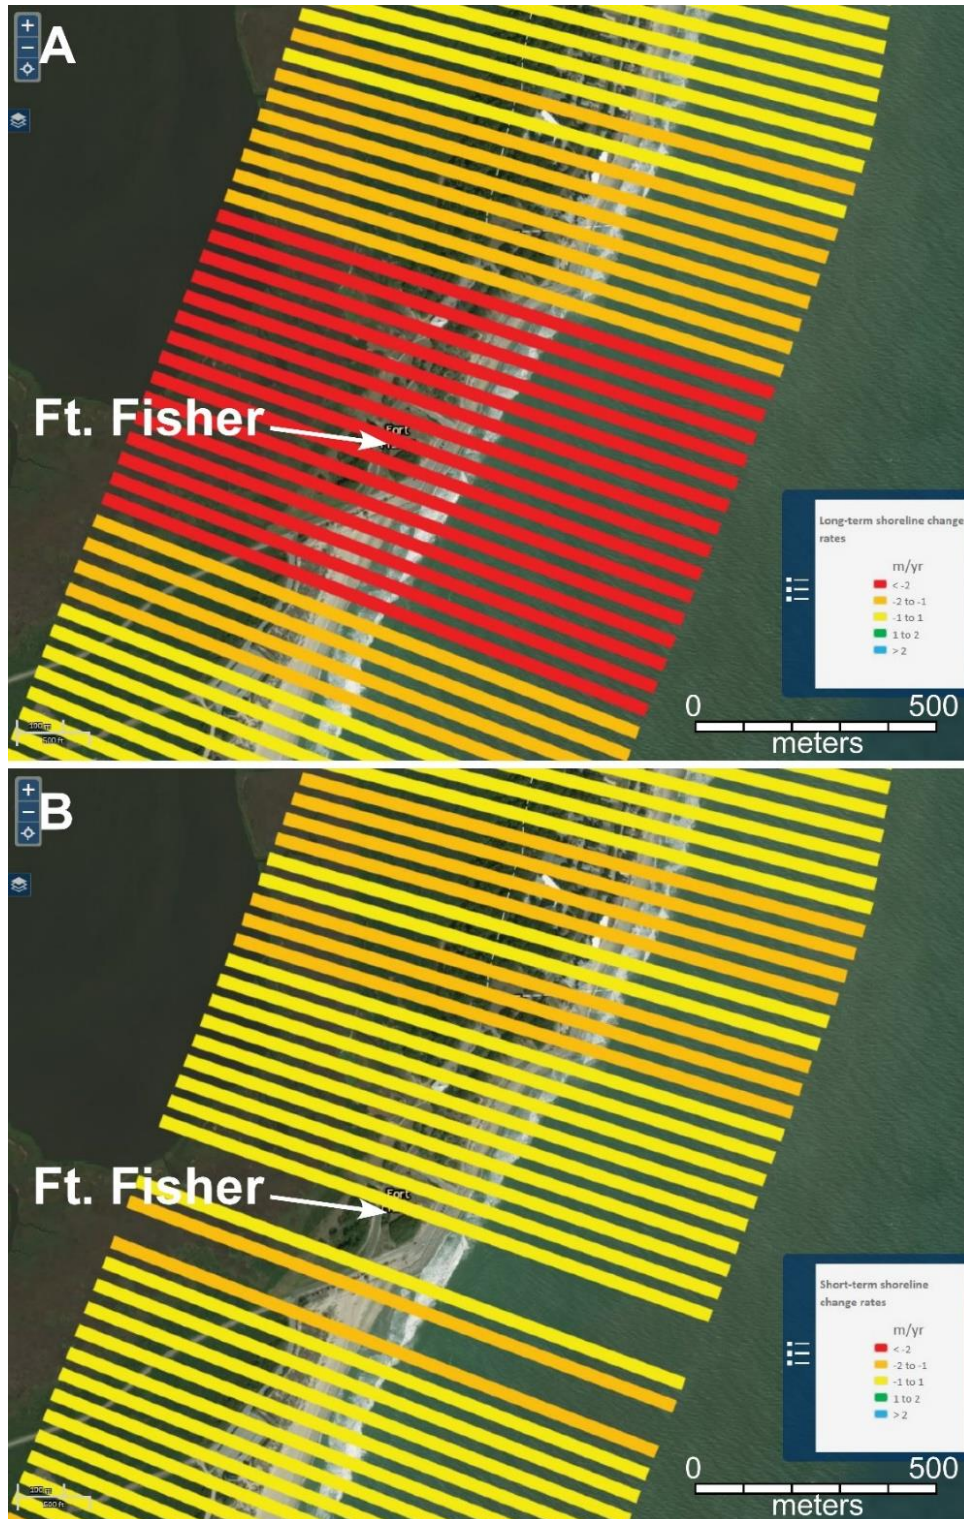
Figure 184. A) Long-term (~70-170 years) shoreline erosion rates based on linear regression analyses (USGS). B) Short-term (~30 years) shoreline erosion rates based on linear regression analyses (USGS) (<https://marine.usgs.gov/coastalchangehazardsportal/>).

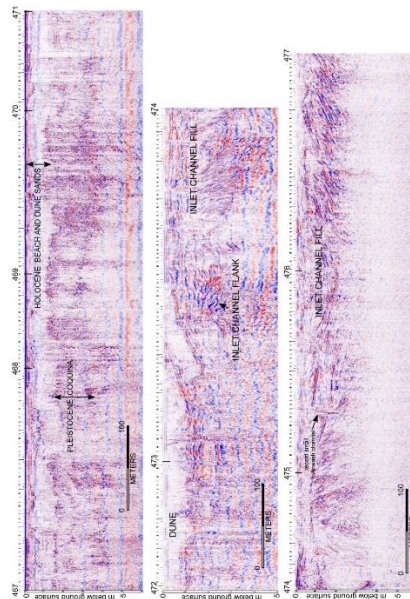
Figure 185. 200 MHz GPR data collected along Highway 421. Numbers along the top of the files are waypoints and correspond to waypoint positions on the map in Figure 1. Several radar

facies are apparent: the Pleistocene coquina (which crops out on the beach to the east), Holocene dune sands, and inlet channel fill sands.

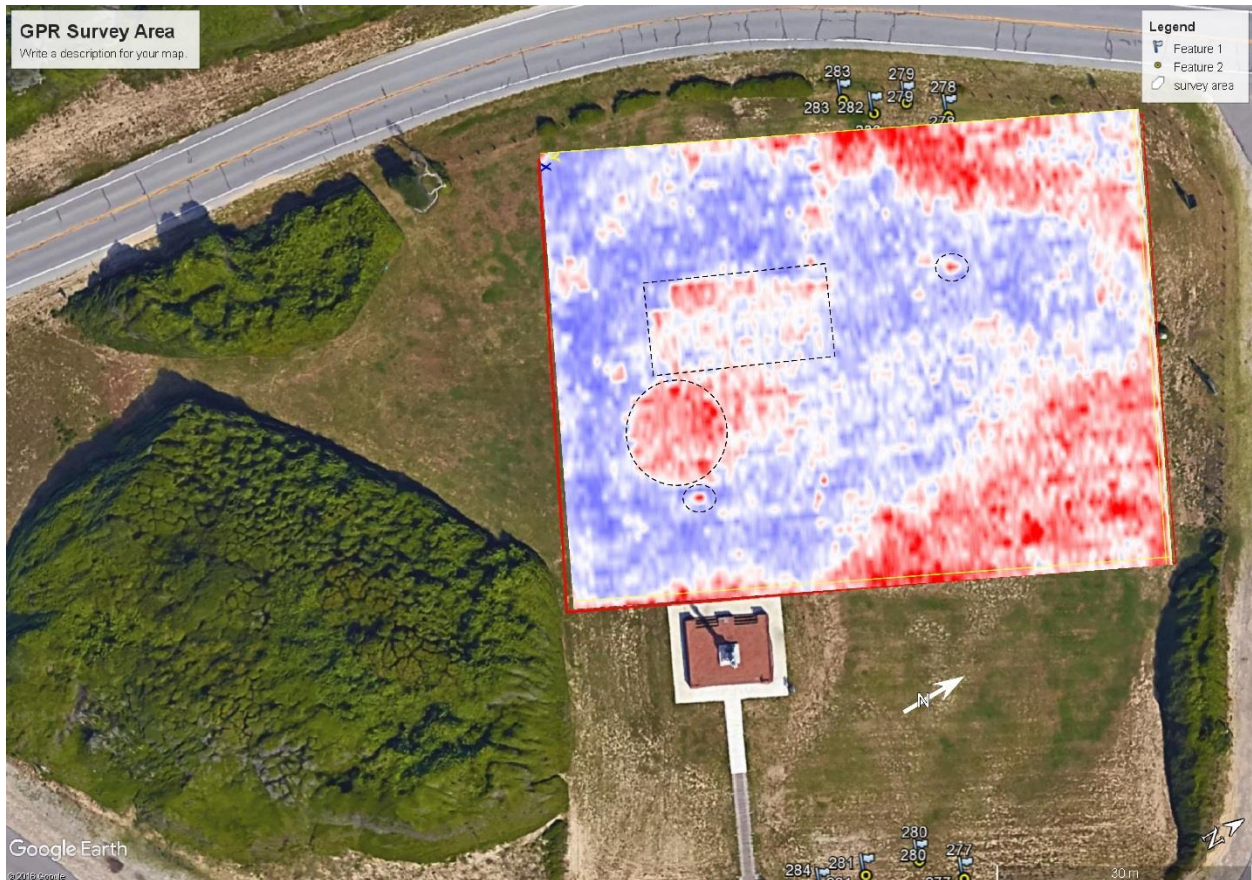
Figure 186. Depth slice (1 m) of 3D GPR data showing the low reflectivity (blue) associated with fine sand and high reflectivity (red) associated with course sand and shells, as well as possible human structures (dashed outlines).

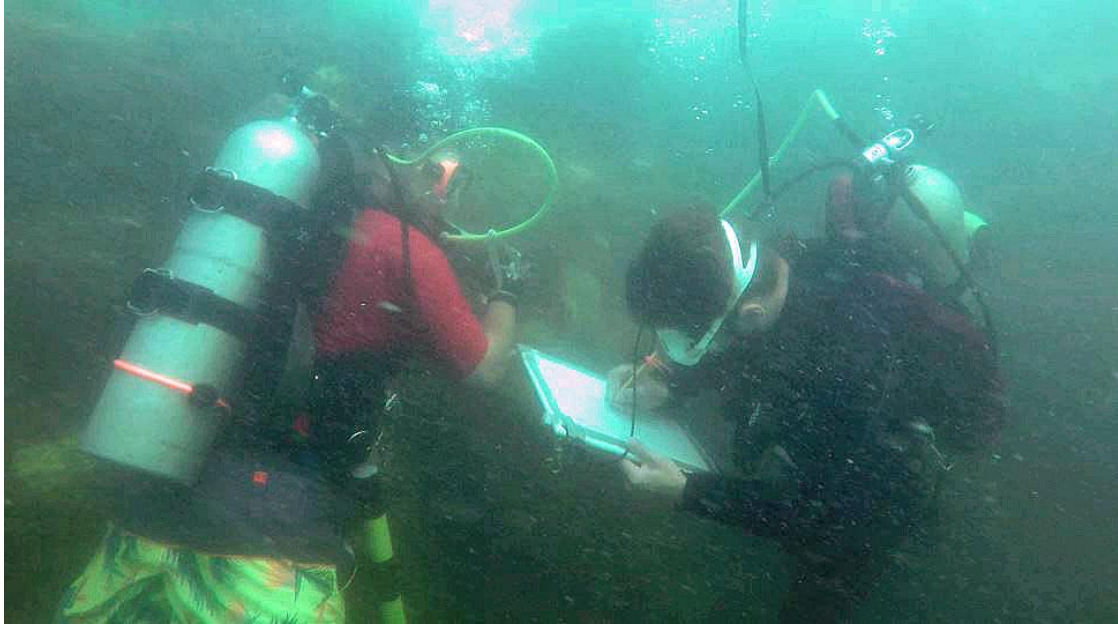
ECU conducted a rapid site assessment of *USS Petershoff*. The most evident change in the site since a video recorded visit in 2012 was a broken bow area. The wreck is a popular fishing site and it is likely that vessels anchoring on or near the wreck, could damage the structure.

Alternatively it could represent structural deterioration, especially the bow area that presents the highest area of relief on the seabed and may lose integrity first. Students noted diagnostic hull

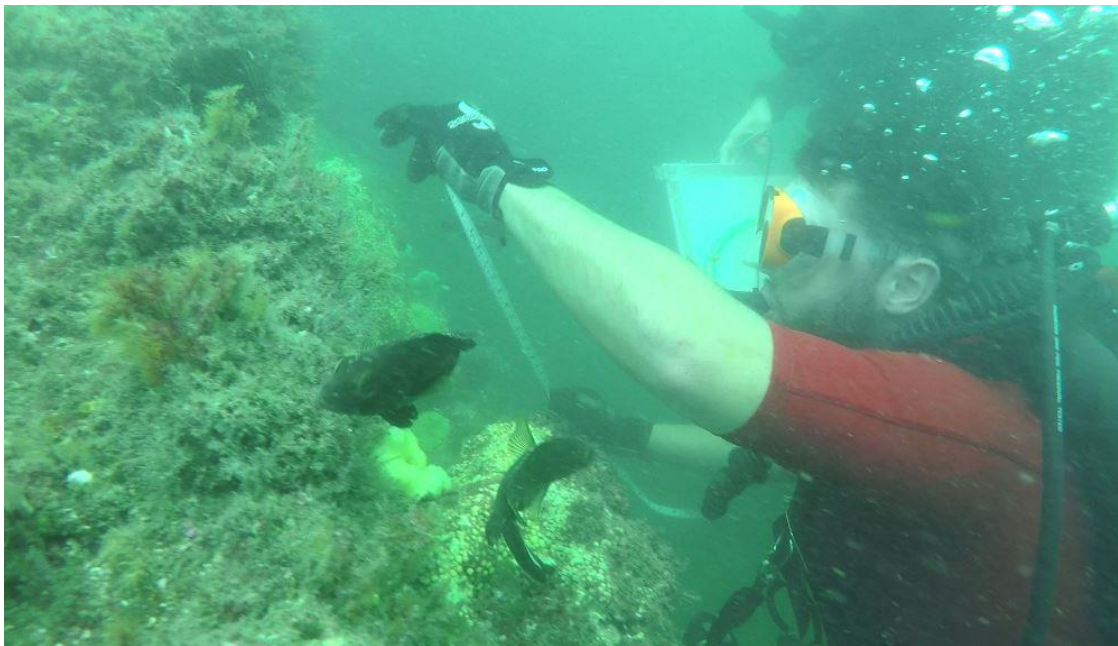
Figure . Gus Adamson recording design features and marine life on the Engine

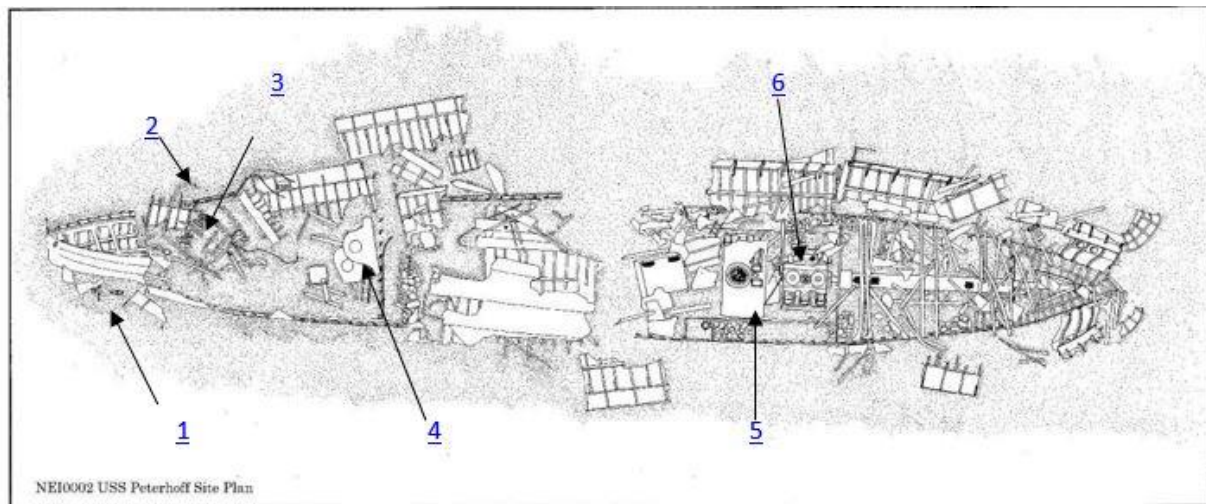
Currently, the wreck is situated within the Fort Fisher Contiguous underwater district and approximately 1.3 miles offshore. It is the wreck furthest out from the coast. The exposed remains of the vessel consist of part of one boiler and a concentration of machinery. The surviving structure has considerable profile and resides on a sand bottom in 34 feet of water. Much of the hull has collapsed, the bow and stern are readily identifiable. The bow lists slightly to starboard and the stern sits on an even keel. Amidships, the engineering space is well defined by the remains of watertight bulkheads fore and aft. Within those bulkheads the boilers and steam engine remain intact. The orientation of the hull is northwest to southeast with the bow to the southeast.

1. Trotman Patent Anchor 2. Davit 3. Windlass 4. Cheek plates 5. Boiler 6. Two inverted direct-acting cylinder steam engines. Image Courtesy of UAB (adapted by Ryan Miranda, ECU).

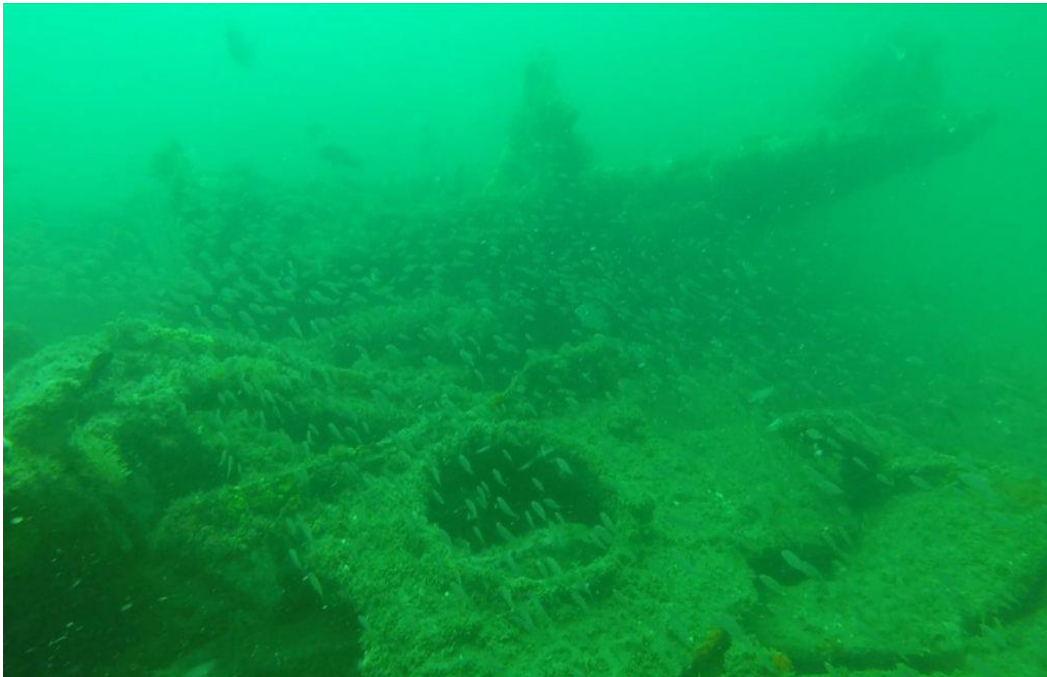
Figure . Cheek Plates in the Bow Area (Photo by Jeremy Borrelli, ECU).

The hull of *Peterhoff* has broken into two distinct elements. The bow, forward of the coal bunkers, and a stern section containing the engineering space amidships and stern. Most of the 120 foot long forward section of the hull has broken down to the turn of the bilge. A 22 foot section of the bow lies on the bottom listing to starboard and extends more than 10 feet into the water column. That section extends from the stem post to the forward hold bulkhead. A Trotman Patent anchor lies off the port bow and two anchor davits and a steam capstan lie within the surviving hull structure. Aft of the forward hold bulkhead, the hull has collapsed to the turn of the bilge and sections of plate and frames from the sides lie adjacent to the hull. Deck beams and small sections of the deck clamps lie on the sand within the confines of the surviving lower hull structure.
