A Preliminary Report of Investigations on the 18th-Century Pillar Dollar Wreck, Biscayne Bay, Florida, USA

The Pillar Dollar Wreck (BISC0035) is located within the boundaries of Biscayne National Park (BNP), Homestead, Florida (Fig. 1). Known locally since the 1960s, it is believed to be a wrecked Spanish galleon that sank sometime in the 18th century. The shipwreck has sparked the interest of adventure seekers, looters, treasure hunters, researchers, and managers who have undertaken a range of activities on site. Its colloquial name is attributed to a type of Spanish coin that was found on site by local adventure seekers who visited the site prior to the implementation of protective legislation and the state of Florida's 1A-31 permit system, which allows for the commercial exploitation of historic shipwrecks. Despite the fact that BNP manages the site and has continuously monitored the location since the 1980s, looting continues today and has irrevocably affected the site. Nevertheless, there is still much to learn about the Pillar Dollar Wreck, particularly about the vessel's origin and construction.

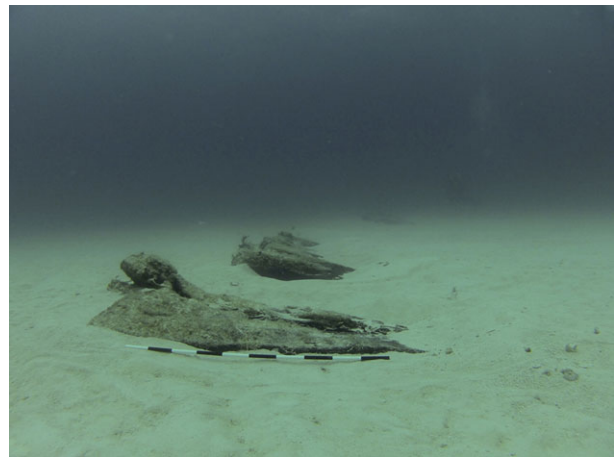
Figure 3. Site photograph of Pillar Dollar Wreck prior to excavation. (McKinnon 2014).

The Pillar Dollar Wreck lies just to the east of Key Largo, Florida, not far from the southern boundary of BNP. Resting in approximately 6.5 m of water (Fig. 3), the shipwreck is buried in the sand and oriented

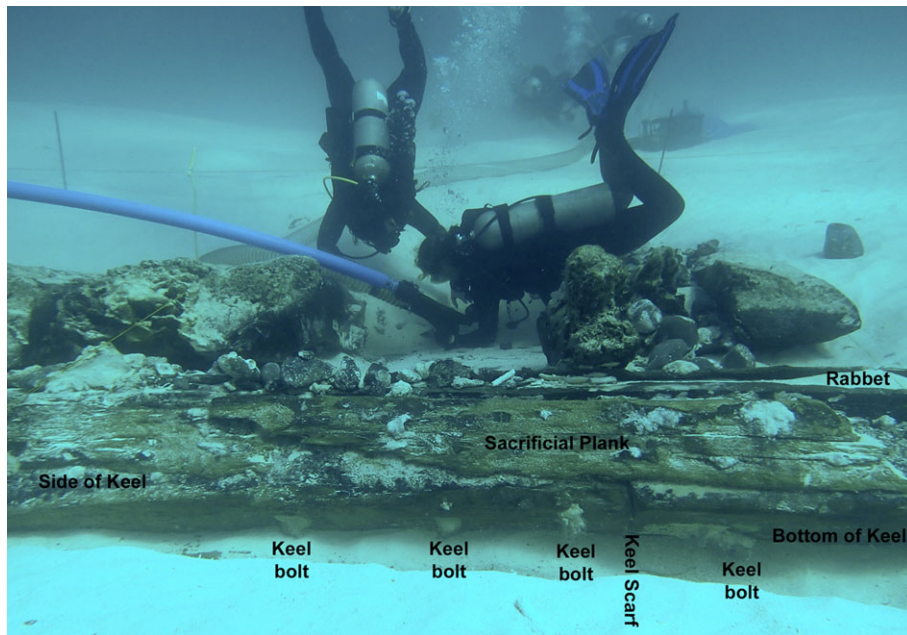
Figure 5. Keel scarf. (McKinnon 2014).

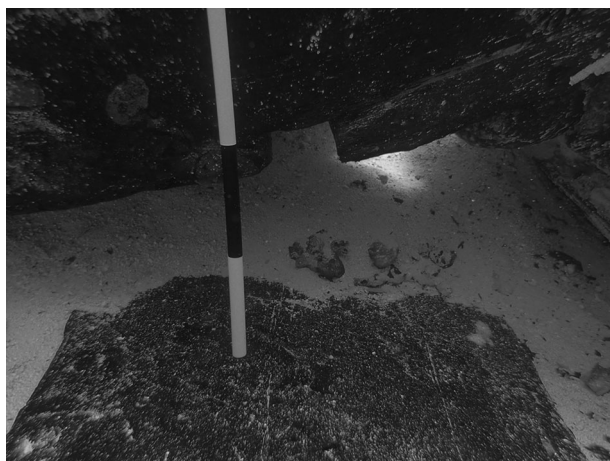
Figure 6. Limber holes. (McKinnon 2014).

additional heavily eroded timber could possibly be a chock, spacer frame, or mast support. The first futtocks feature a butt end and many still exhibit tool marks from being hewn. The matching floor-timbers are eroded where they would be fastened through the keel. The floor-timber and futtock pairs are fastened laterally together by large square iron bolts. The lengths of the floors and futtocks remain unknown because they continue into the sand beyond the depth (~0.60 m) of excavation. Limber holes run through all of the floors and average 70×40 mm (Fig. 6).

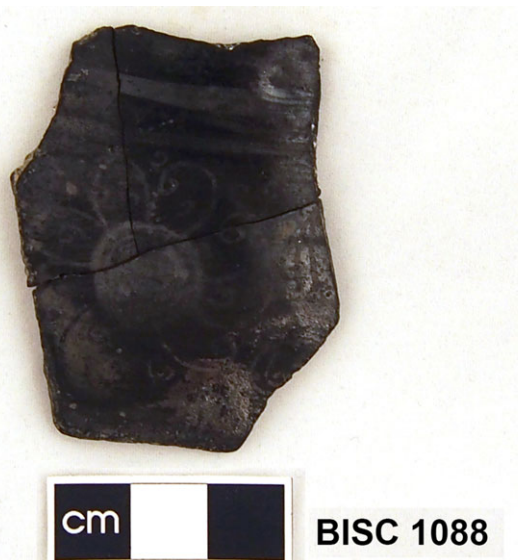
Figure 7. Guadalajara polychrome sherd. (McKinnon 2014).

type of storage jar. One piece of tin-enamelled coarse earthenware, possibly majolica, with a blue-on-white or blue-on-blue linear design was recovered. Five pieces of Guadalajara polychrome—three of which come from the same ceramic vessel—were identified by their paste and decoration (Fig. 7). Guadalajara polychrome, also known as Mexican Type-A ware, Aztec IV, Tonalá ware, Tonalá Bruñida ware, or ‘native Aztec pottery’, was manufactured in central Mexico (Fairbanks, 1972). The dates for its production are disputed, with Charlton and Katz (1979) indicating 1650–1810 and Barnes (1980) stating 1780–1830. It was a slipped, burnished coarse earthenware used mostly for storing and serving food and beverages, and in particular was commonly used for storing water due to the porosity of the clay that allowed for evaporation and kept the water cooler
